Innovative Refurbishment, Garth House, Bicester

Final report
1204_DECC_Phase 2
Final Version – 15 January 2016

Submitted to:
Innovate UK

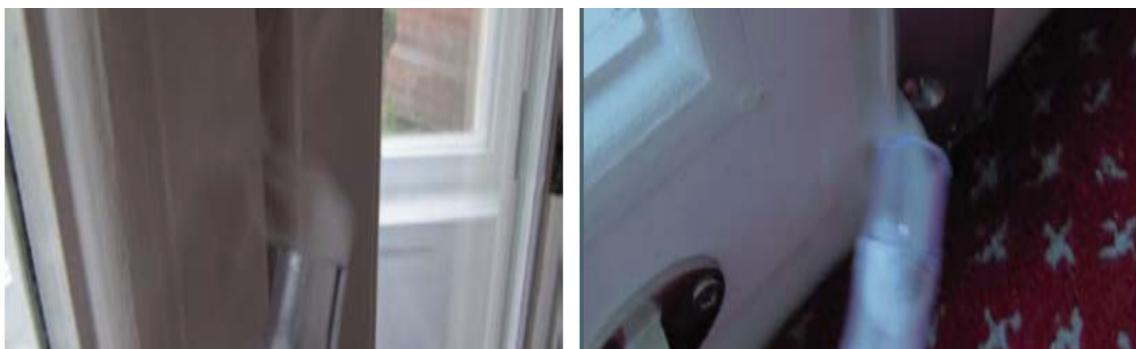
Ground and first floors: There were a number of air leakage paths into the floor void. This occurred around door frames, skirtings, the kitchen, and rooms where the floor boards were exposed. It was not determined whether this air was travelling within the floor void to other parts of the building outside the test zone, or was finding its way out of the building around gaps in the insulated plasterboard or holes in the external wall. Regarding secondary glazing, the seal between openable doors was frequently not in contact with the adjoining door and often the seals stopped short at the tops and bottoms, leaving a gap. The secondary glazing frame did not always seem to be sealed to the floor and air was drawn under the frame. On the first floor, air was drawn under the floor around the perimeter of most of the rooms.

Figure 1 Secondary glazing seals. Smoke drawn through secondary glazing.

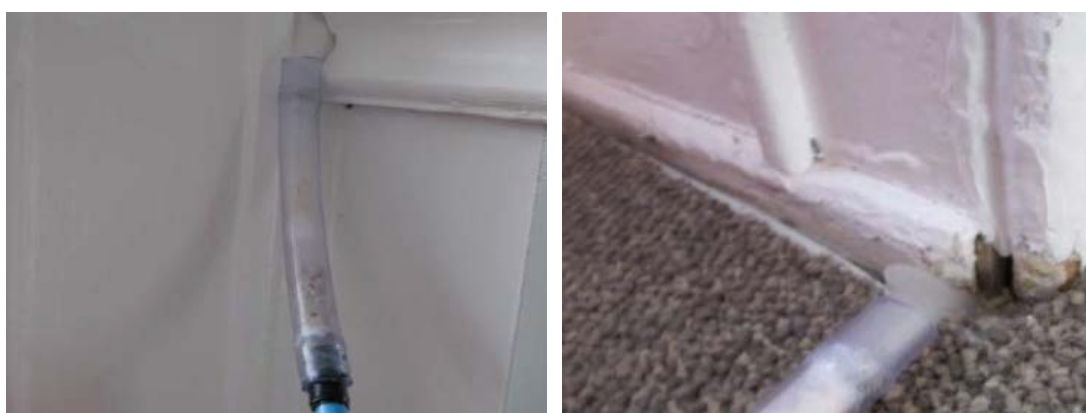
Figure 6 Smoke drawn behind end of dado detail and at bottom of window reveal

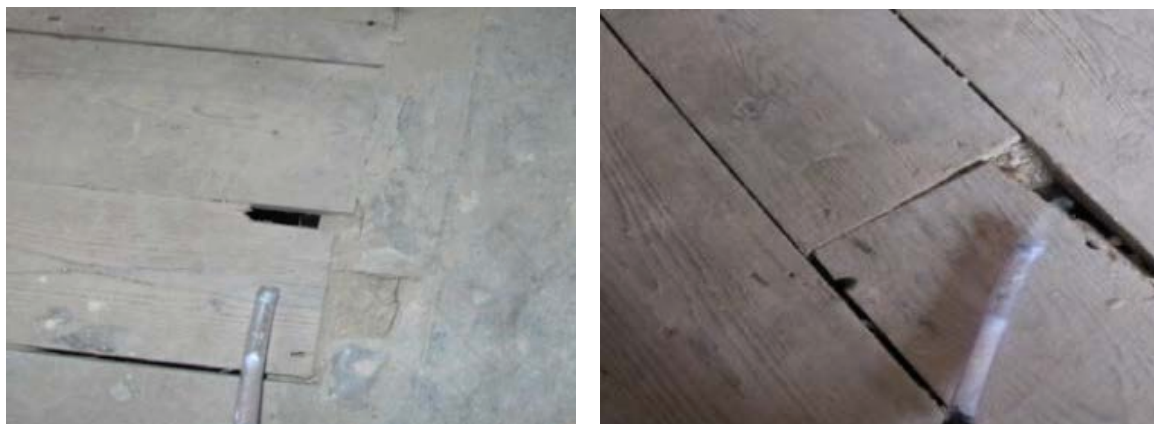
Attic space: In the attic space there was a strong draw of air through all the floor boards in every room. The air movement caused by the air leakage path resulted in a rapid dissipation of smoke, as a result of which the smoke was difficult to record photographically. It is not known whether this air was traveling within the floor void and leaking into the un-refurbished area or whether there were leakage paths through the exterior fabric of the building. The cupboard where the MVHR unit was located had large holes around the penetrations for the ducting. There does not appear to be an effective air seal. It is not known whether the air seal is intended to be the floor covering or whether the floorboards should be lifted to create an air seal underneath.

Figure 7 Gaps in floor. Smoke drawn under floor.

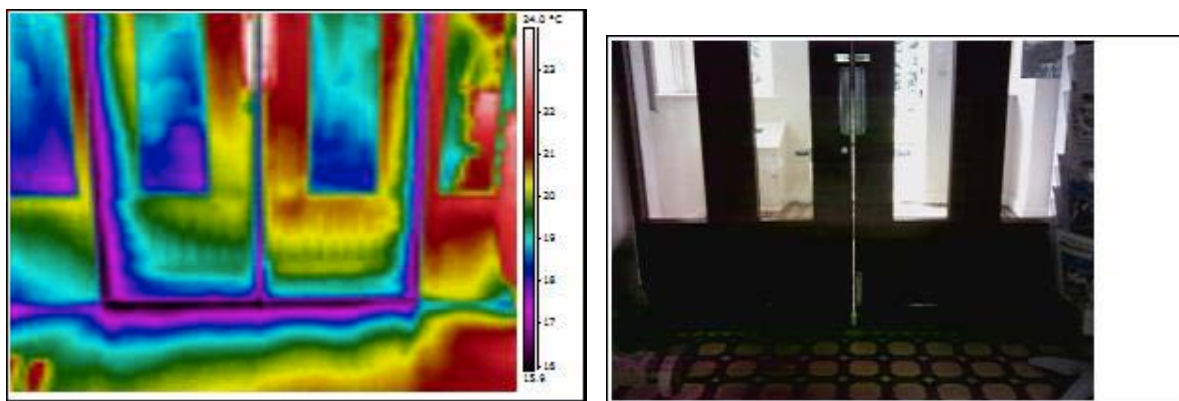
Figure 15 Room G23. Cold air leakage through the door.

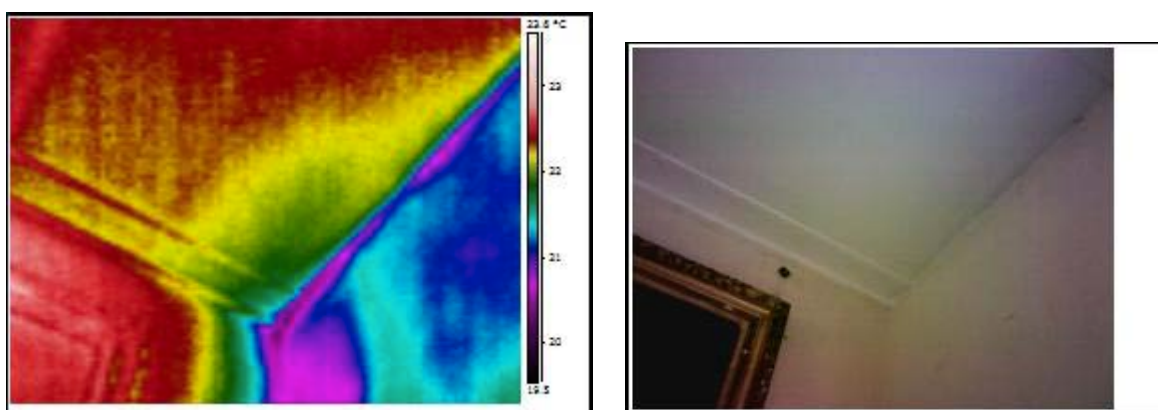
Figure 16 Room F18. Well insulated roof and poor insulated external wall.

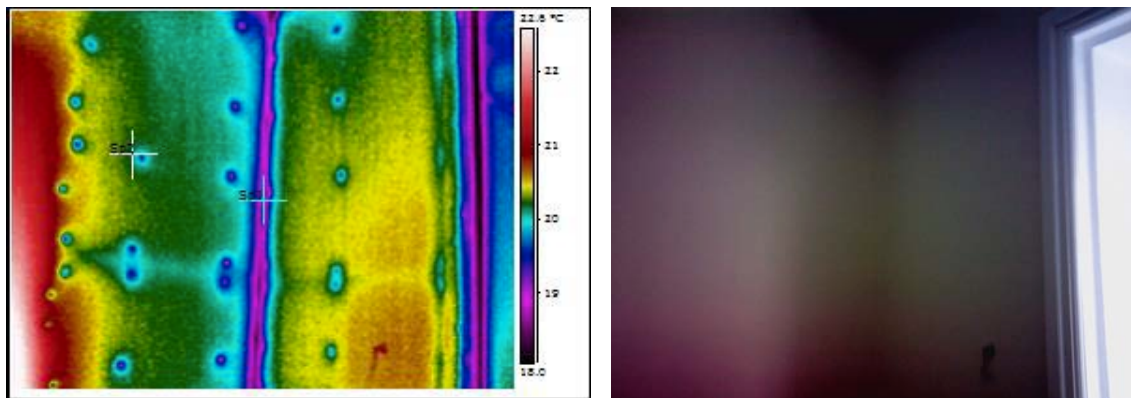
Figure 27 Room F10. First floor office. Thermal bridge at the junction of the external wall. It also shows the fixing points of the insulation panels. This pattern can be found all over the building.

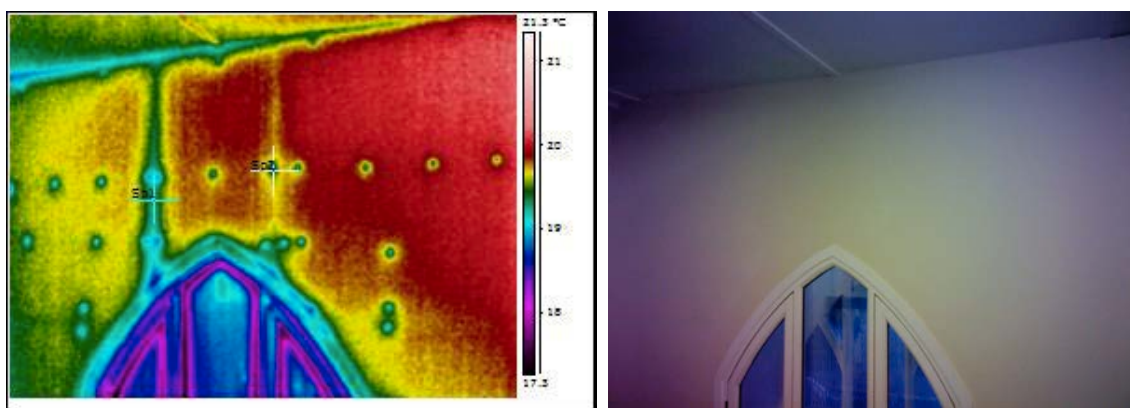
Figure 30 Staircase hallway. The image shows the thermal bridge at the gap between insulation panels. It also shows the fixing points of insulation panels. This pattern can be found all over the building.

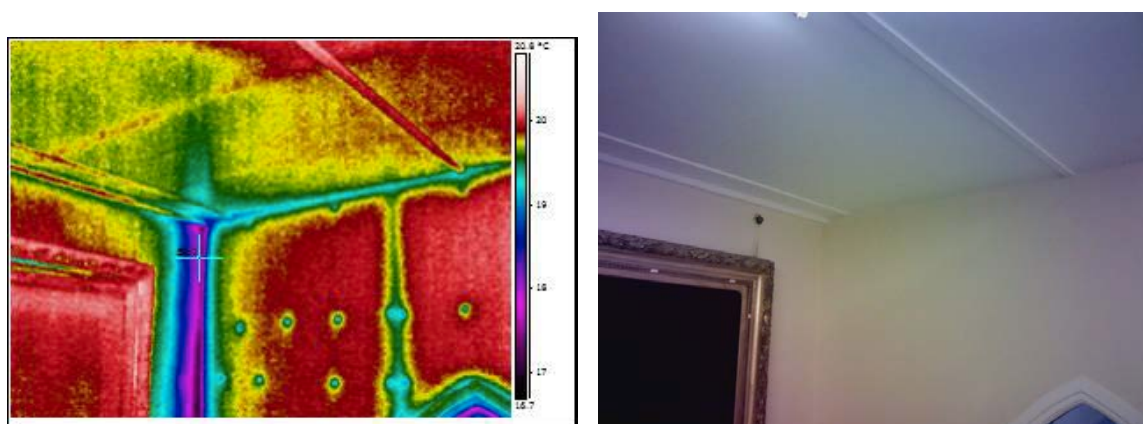
Figure 31 Staircase hallway. The image shows the thermal bridge at the junction of internal wall and external wall. Because the building is internally insulated, it is expected to see such a thermal bridge. It also shows the fixing points of insulation panels. This pattern can be found all over the building.

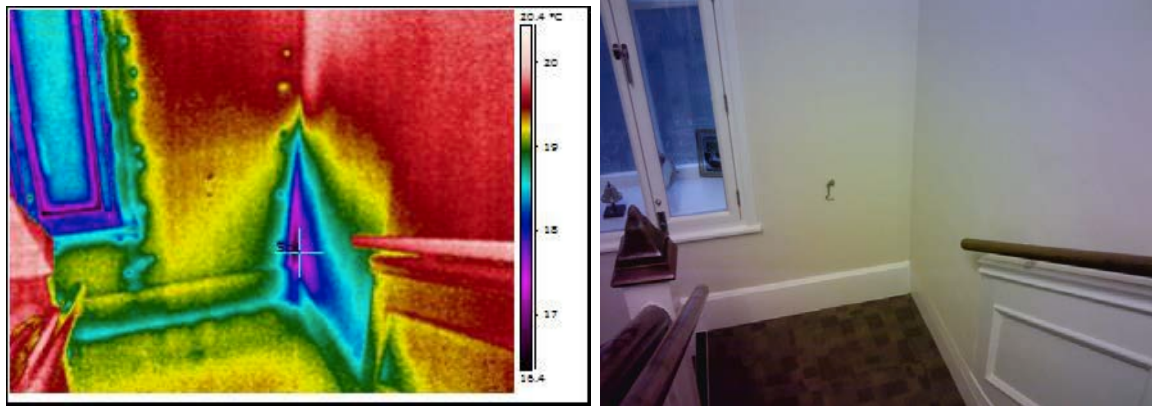
Figure 32 Staircase hallway. The image shows the thermal bridge at the junction of internal wall and external wall.

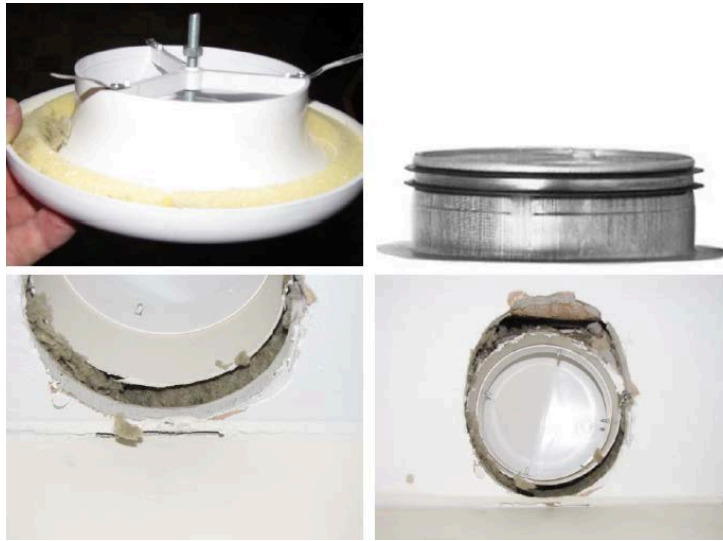
possible adjustment to the air flow distribution will be via these valves. It is essential that these are adjusted and commissioned correctly.

Figure 43 i) top left-diffuser showing untightened locking nut. ii) top right-an example of a gasketed flange spigot. iii) bottom left-gap between duct end and ceiling. iv) bottom right-oversized cut outs in plasterboard.

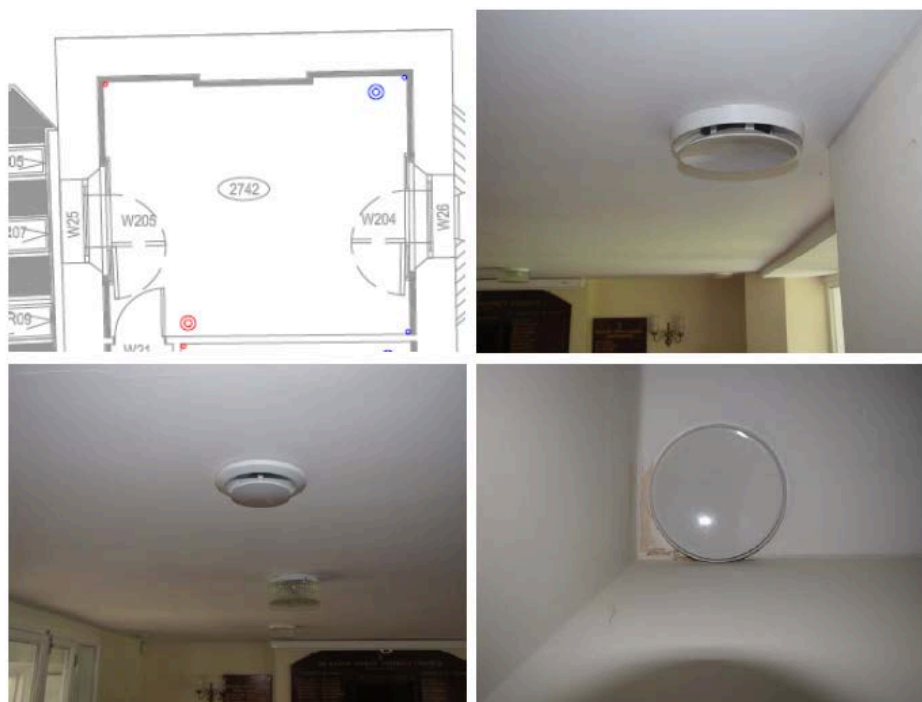
There was found to be a general mix up of ceiling valves selected for supply and extract air. In 8 out of 9 instances, supply air valves have been used on extract terminals. In 7 out of 9 instances, extract air valves have been used on supply air terminals. The Passivent drawings show the room terminals: the positions of which have broadly been followed. However, Figure 44 i), which is an extract from the Passivent drawings, shows that blue terminals are intended as supply, and red are intended as extract. Whilst the positions have been maintained, the blue is in fact extract, and red is supply. Despite this change (reason unknown), the terminal valves types have been fitted, generally in accordance with the drawing, e.g. extract terminals fitted in the right place according to drawing, although the duct is a supply duct.

Figure 44 i) top left-excerpt from Passivent drawing. ii) top right-a supply air valve used as extract.

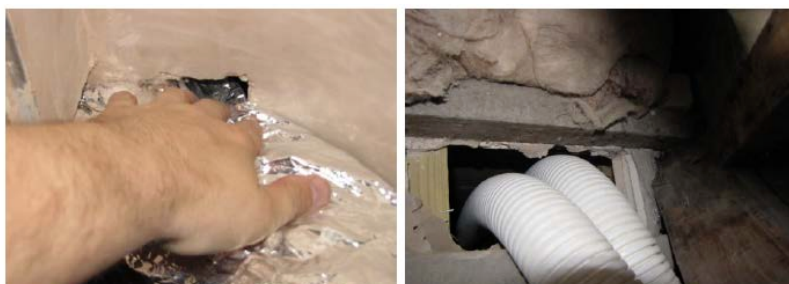
The intake and exhaust ducts are insulated, 180mm dia flexible ducts. These run within the cold loft and terminate in roof slate ventilator tiles. The size of the intake and exhaust tiles (free area) could not be ascertained during the survey, but the measured air flows (see next section) suggest these are sufficiently sized. As the ducts pass between the cold loft and the second floor ceiling, air gaps are present, which will contribute to the overall air leakage of the building – see Figure 46 i).

Figure 46 i) Left – intake and exhaust duct – air leakage around ceiling penetrations. ii) Middle – supply and extract ducts to office accommodation below – uninsulated in cold zone and unsealed at head of riser.
