Innovative Refurbishment, Garth House, Bicester

Final report
1204_DECC_Phase 2
Final Version – 15 January 2016

Submitted to:
Innovate UK

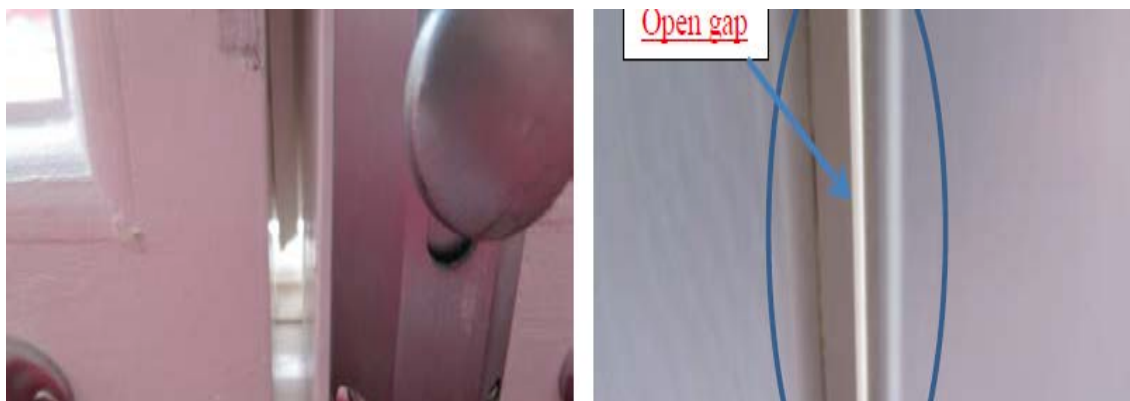
Figure 2 Secondary glazing seals. The seals between the two doors do not extend down to the bottom/sill/threshold/ step.

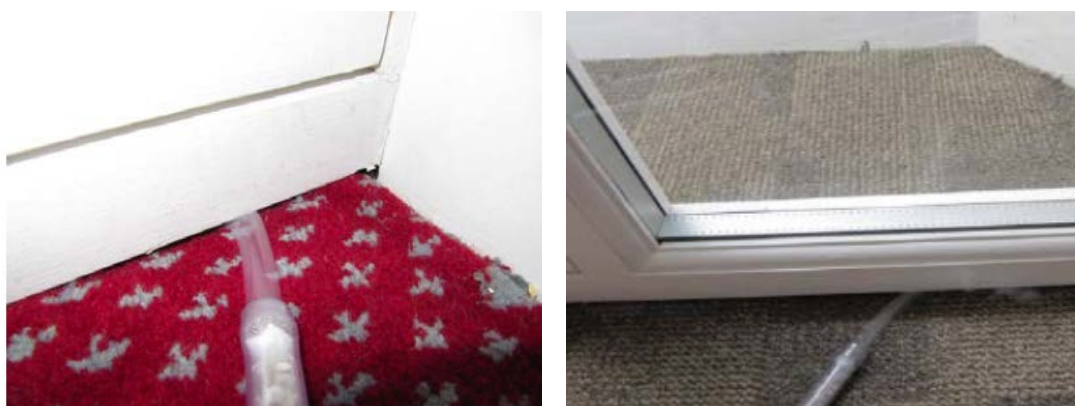
Figure 3 Secondary glazing frame. Air is drawn through the gap between the secondary glazing and the carpet.

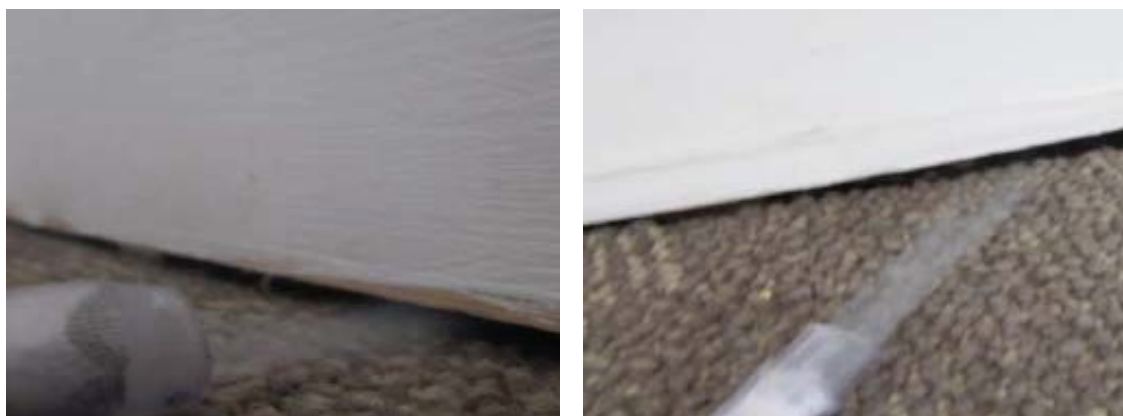
Figure 4 Smoke drawn through gap between floor and skirtings.

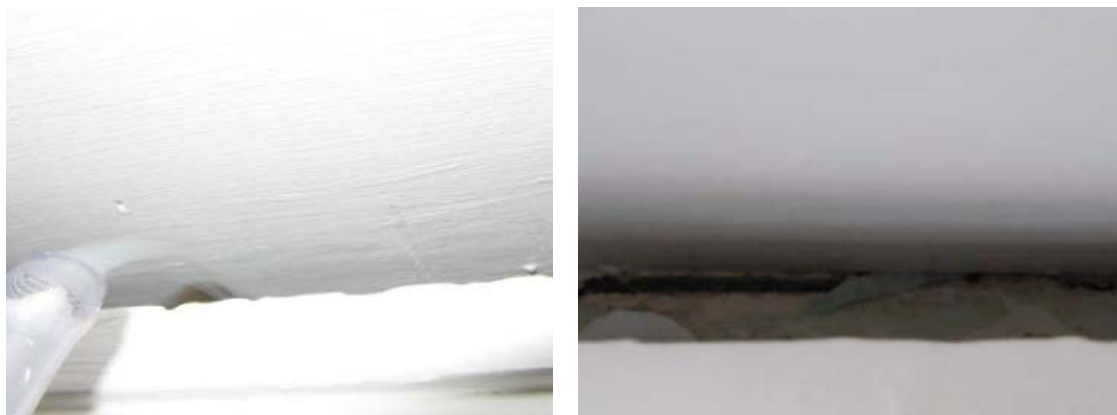
Figure 5 Smoke drawn over top of windows. Gaps visible above windows.

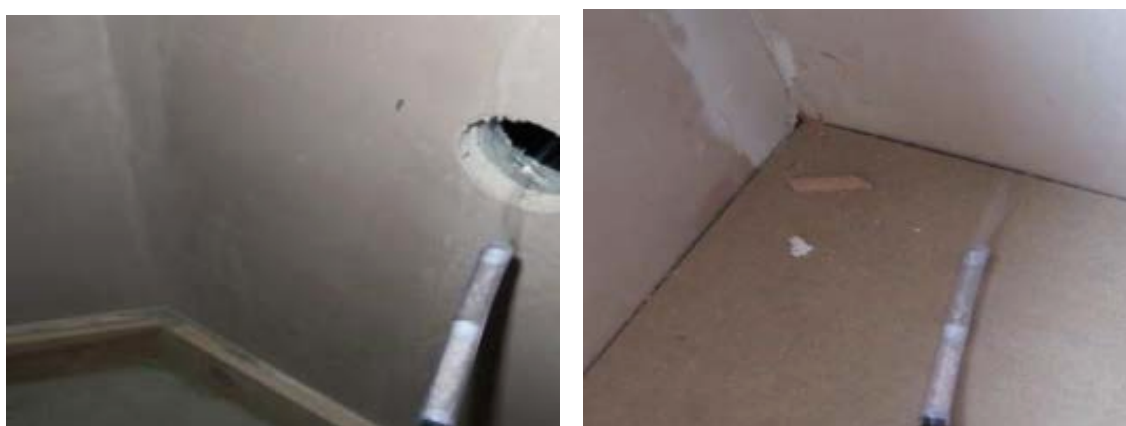
Figure 8 Left: Smoke drawn through hole in pitched ceiling. Right: Smoke drawn through floor perimeter

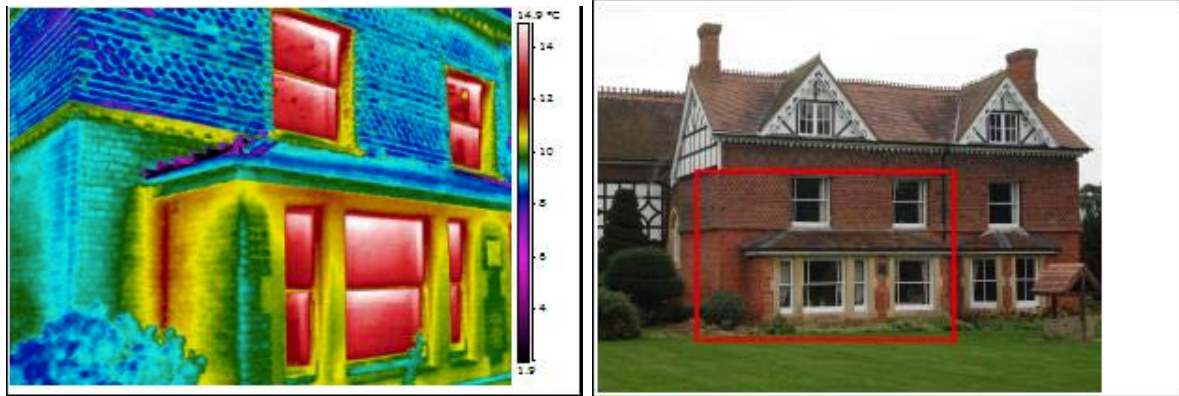
Figure 9 Southwest elevation. The image shows significant heat loss through windows and heat loss through the wall junction.

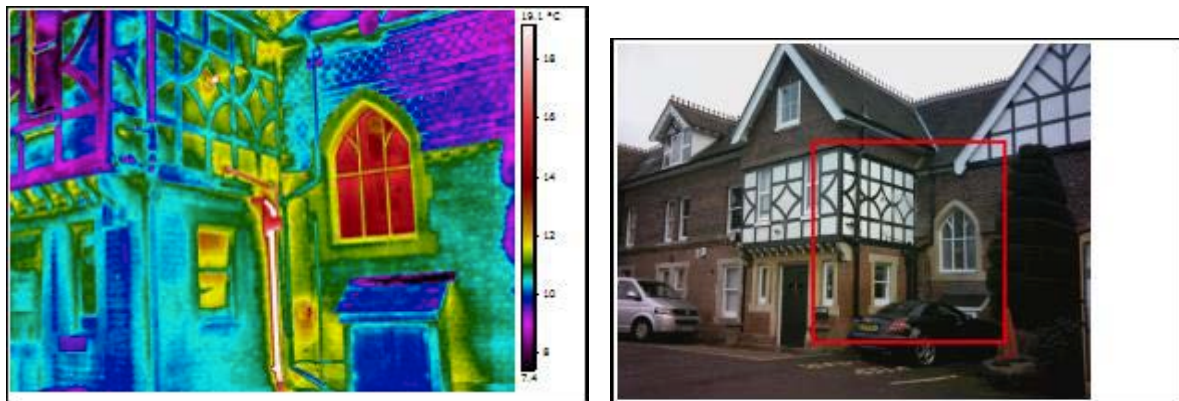
Figure 10 Front elevation (northwest). The image shows significant heat loss through windows and heat loss through white painted wall.

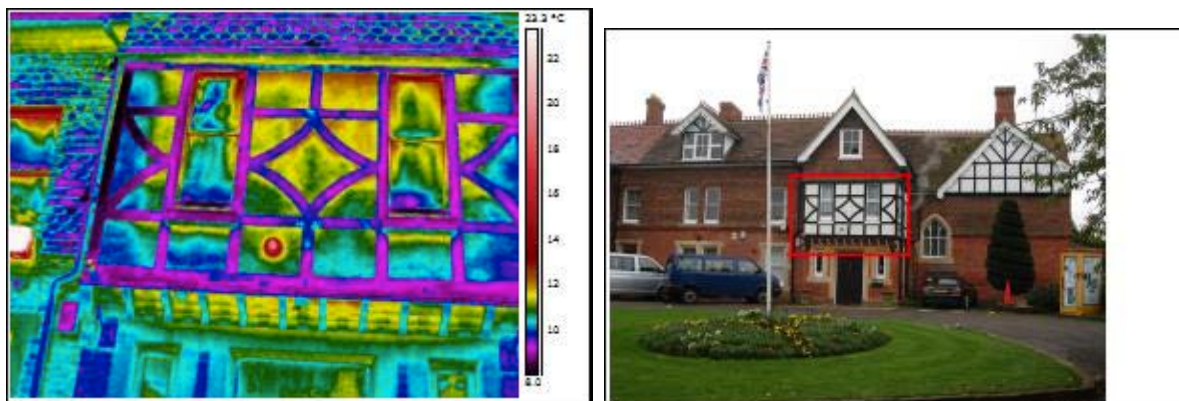
Figure 11 Front elevation (northwest). The image shows the heat loss through white painted wall. It is likely to be due to poor insulation of external wall.

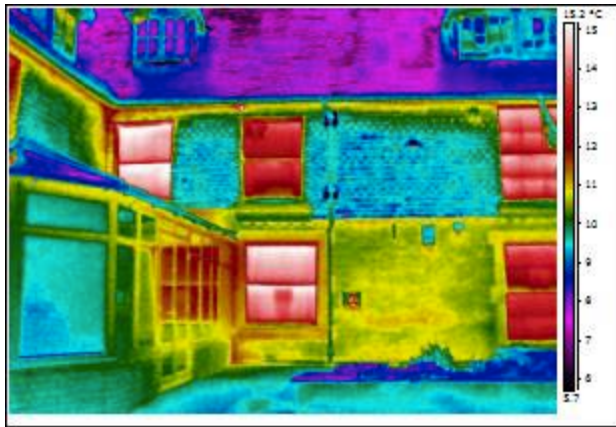
Figure 12 Back elevation (east). The image shows the heat loss through external wall at ground floor. It is likely to be due to poor insulation of external wall.

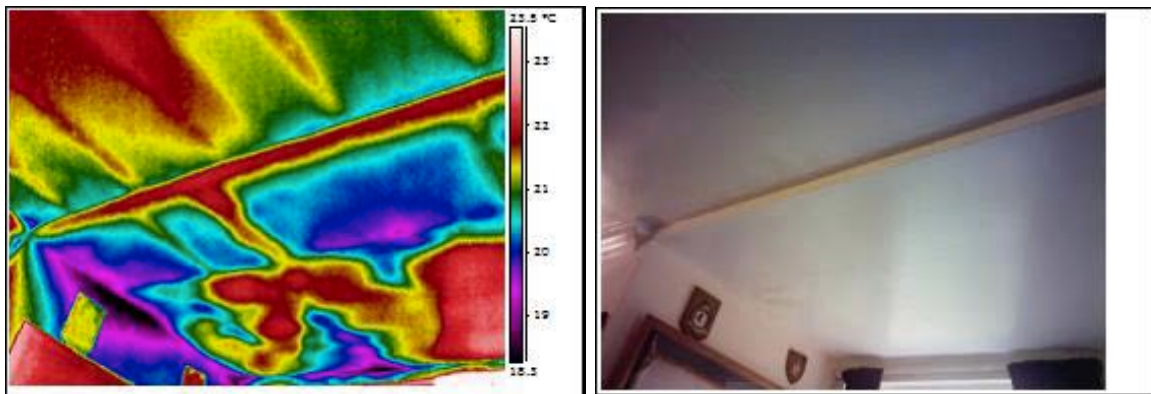
Figure 13 Room G25. The image shows thermal anomalies on the ceiling of meeting room at ground floor. It is likely to be due to poor insulation of pitched roof above windows.

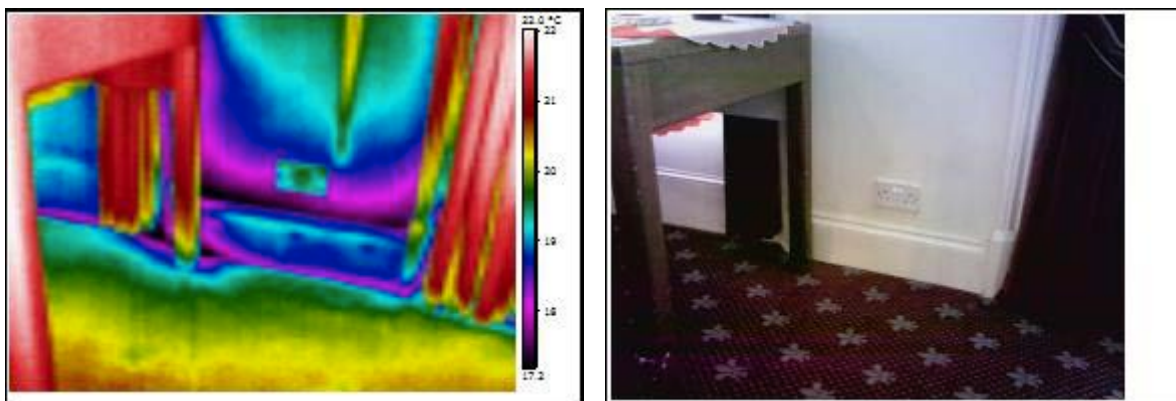
Figure 14 Room G25. The image shows the heat loss through wall-floor junction in the meeting room on the ground floor.

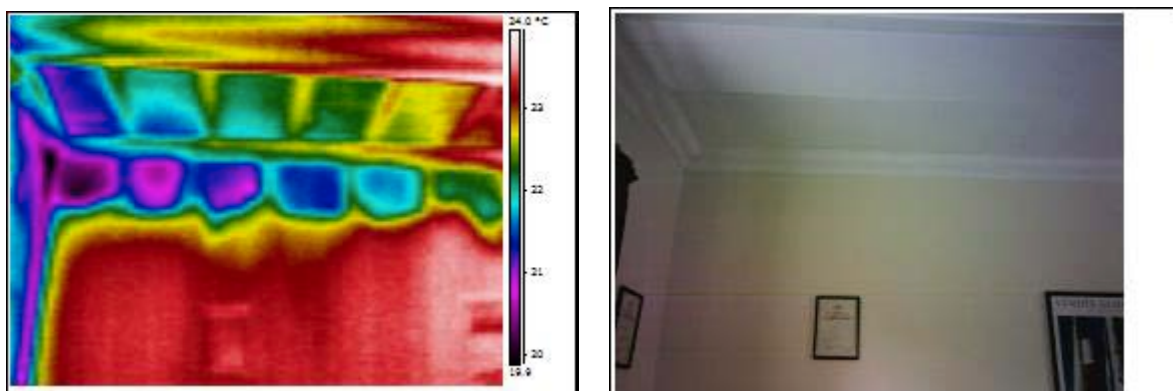
Figure 17 Room F21. The image shows thermal anomalies at the wall-roof junction in room F21 at first floor. It is likely to be due to the build process of recent roof installation.

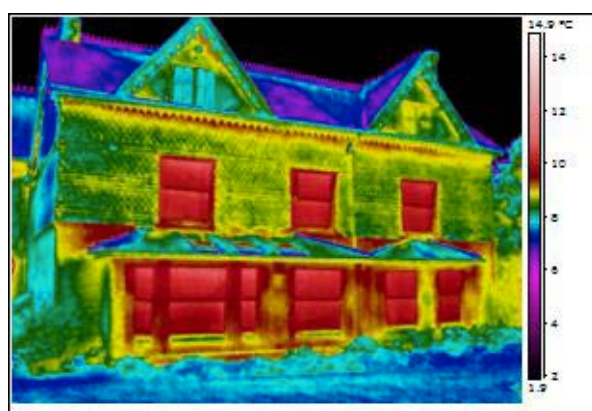
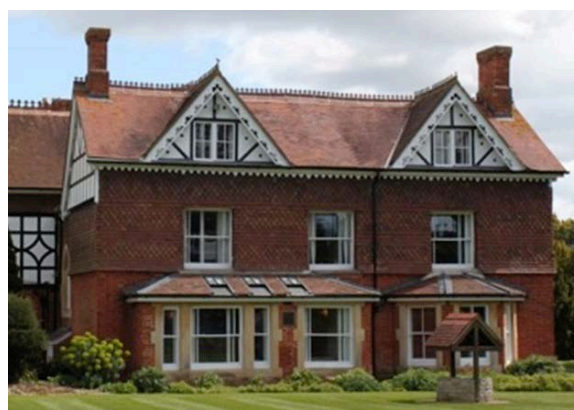
Figure 18 South elevation. The image shows the heat loss through roof-wall junction at the floor line of second floor.

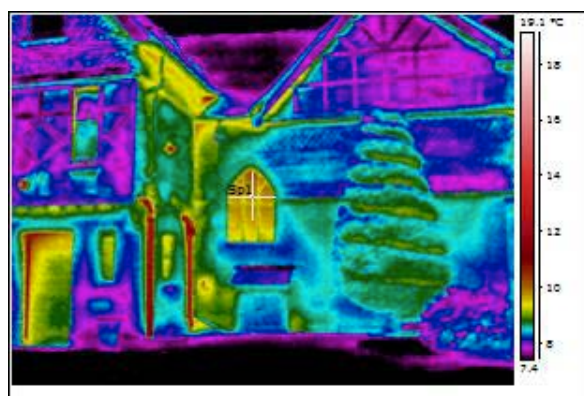
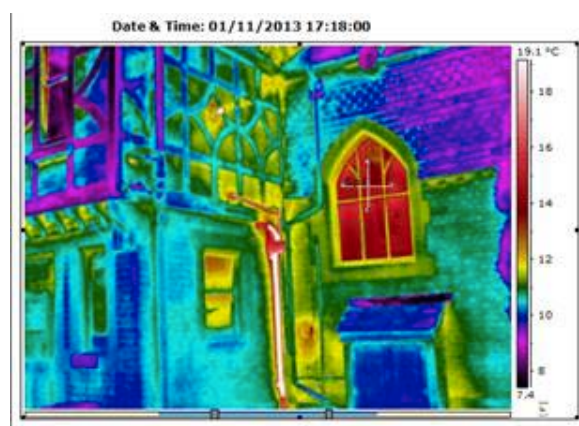
Figure 19 Left: After refurbishment (indoor 23.2 °C, outdoor 10.2 °C). Right: Before refurbishment (indoor 24 °C, outdoor 13.3 °C). The temperature at Sp1 is higher before refurbishment comparing the temperature after refurbishment. The comparison shows that the heat loss through windows after refurbishment is less than the heat loss before refurbishment.

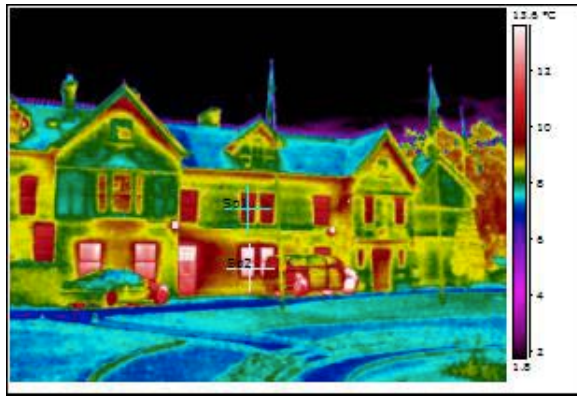
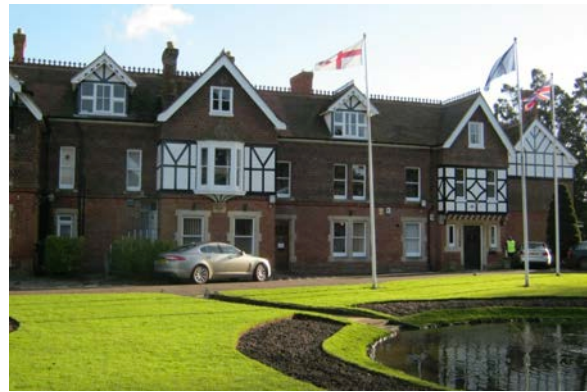
Figure 20 West elevation. The windows at ground floor are significantly warmer than the windows at first floor, as the secondary glazing is installed for windows at the first floor.

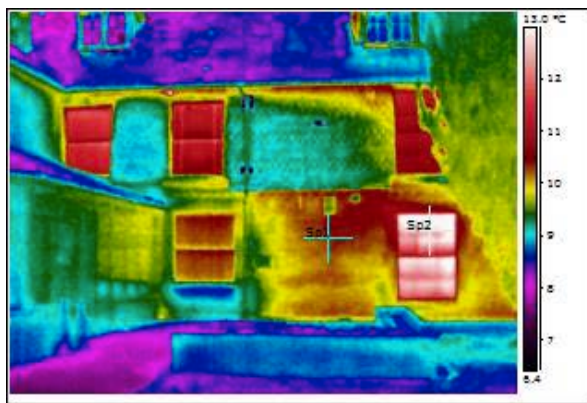
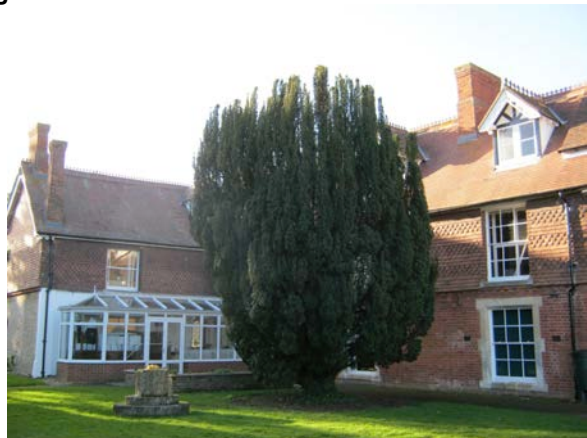
Figure 21 East elevation. The registry office is not insulated as part of this project. The image shows significant higher heat loss through windows and external wall of the registry office.

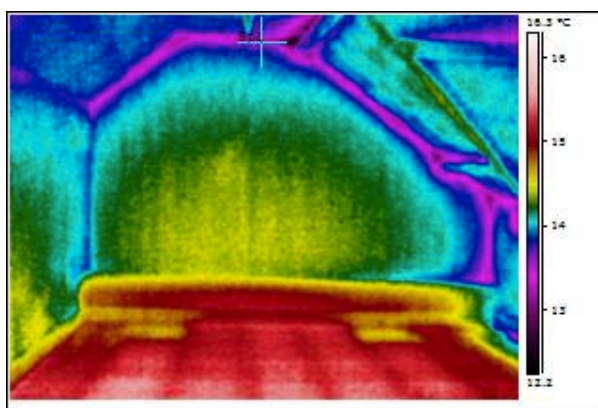
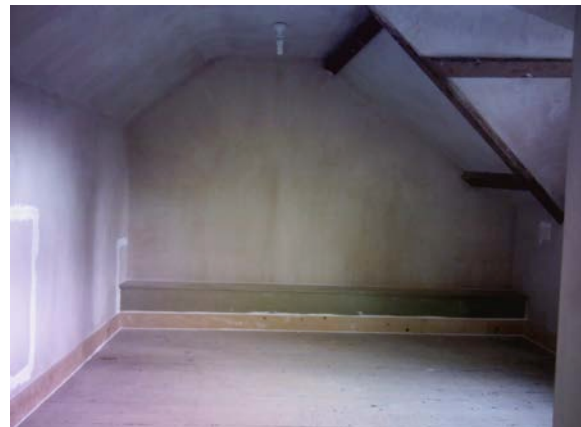
Figure 22 Room S19, attic space. The image shows thermal bridges at the junctions between the external wall and roof in the second floor.

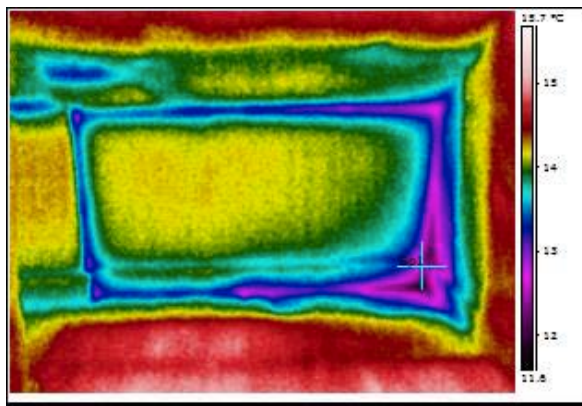
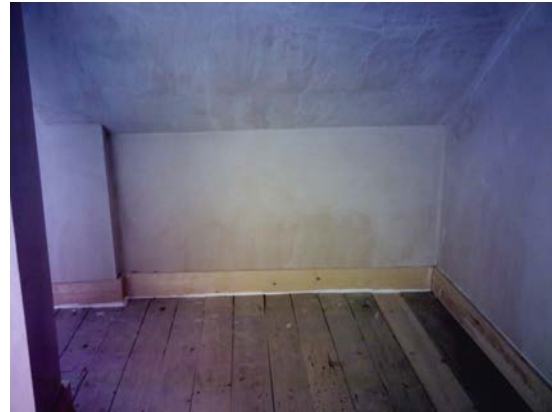
Figure 23 Room S18, attic space. The image shows thermal bridges at the junctions between external wall and roof in the second floor.

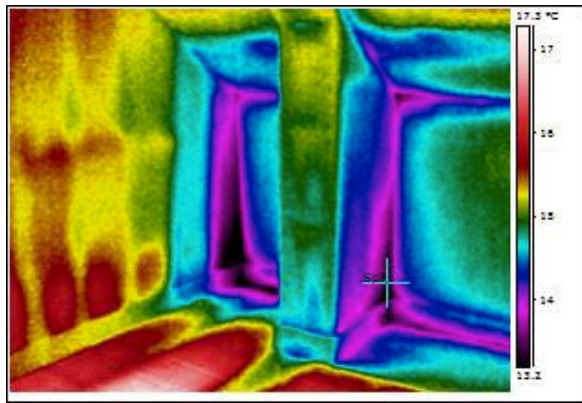
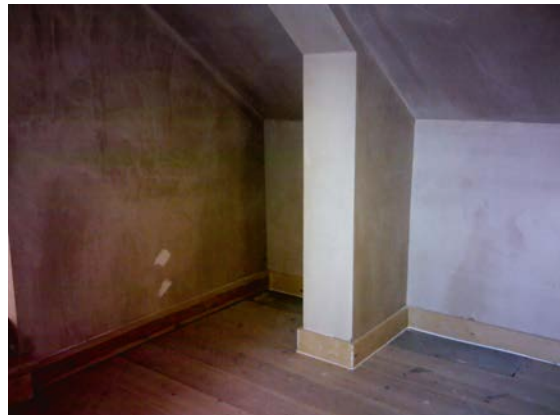
Figure 24 Room S18, attic space. The image shows thermal bridges at the junctions between external wall and structural beam in the second floor.

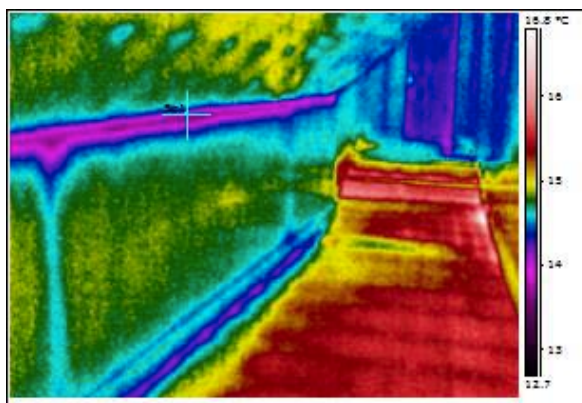
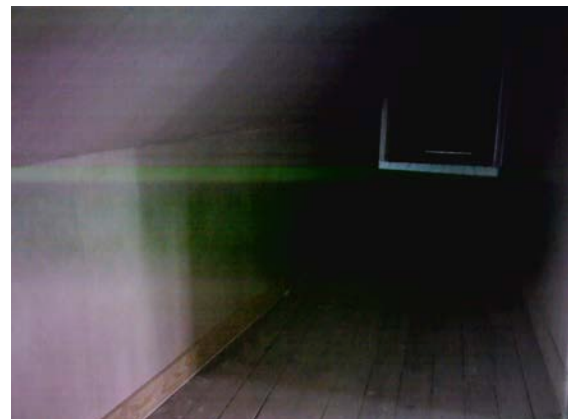
Figure 25 Room S12, attic space. The image shows thermal bridges at the junctions between wall and roof in the second floor.

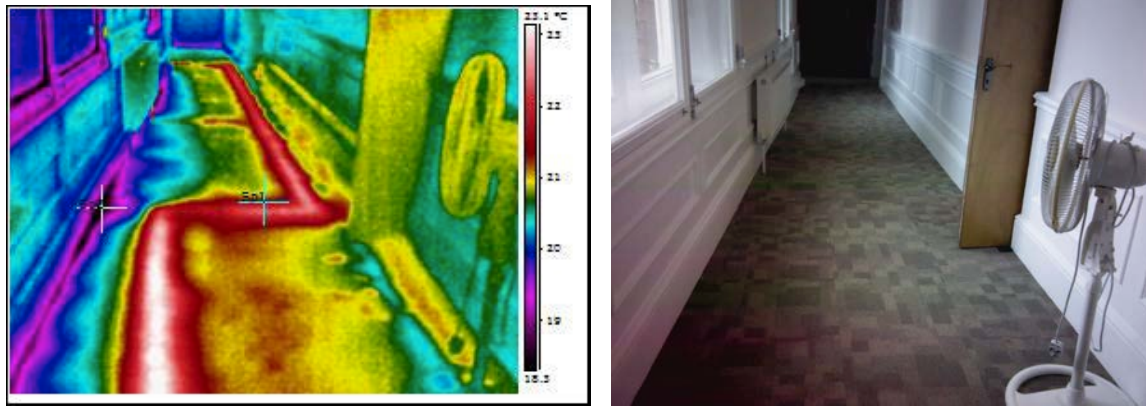
Figure 26 Room F09, First floor corridor. New heating pipe (underfloor) for radiator in F10. The image also shows the thermal bridges at the junction of external wall and first floor line.

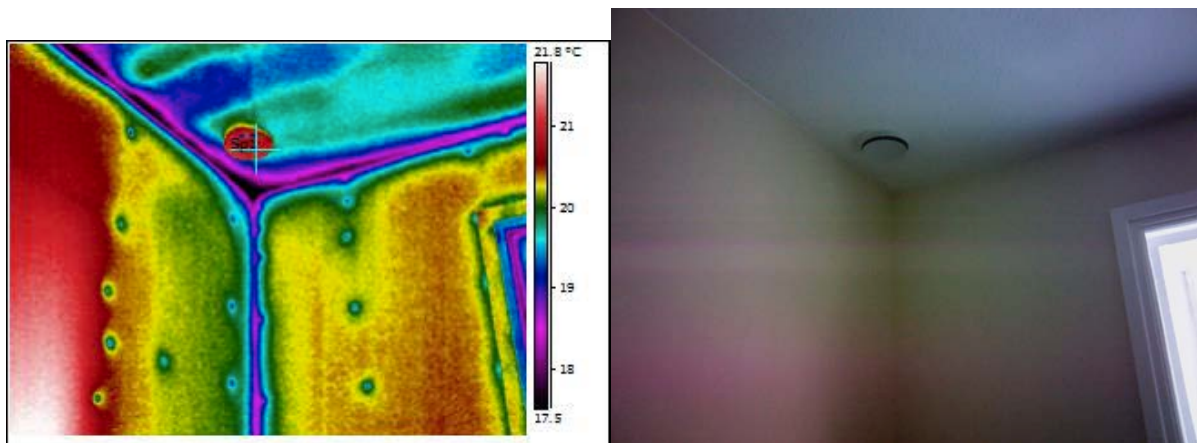
Figure 28 Room F10, First floor office. The red point shows the air outlet for MVHR system.

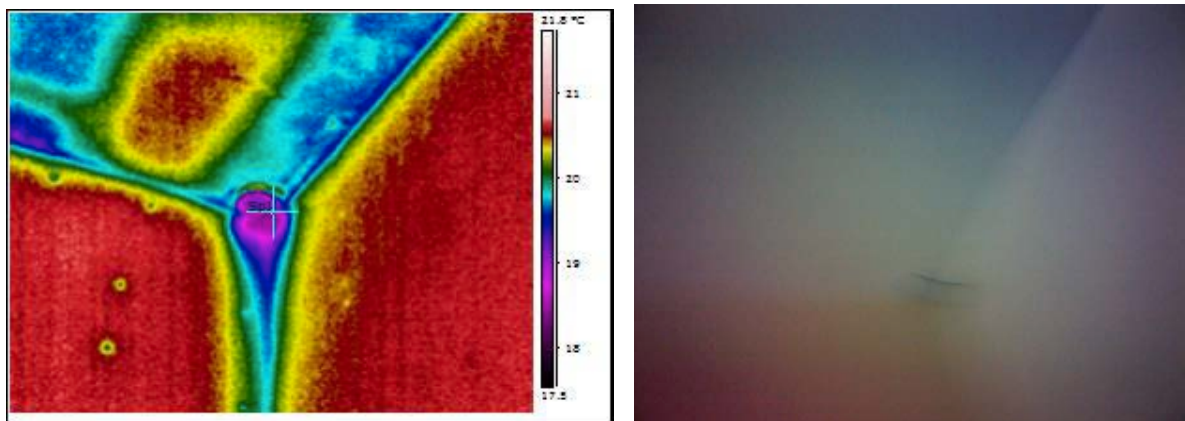
Figure 29 Room F10, First floor office. The purple point shows the air inlet of MVHR system. The temperature of fresh air is generally 2-3 °C lower than the temperature of indoor air.

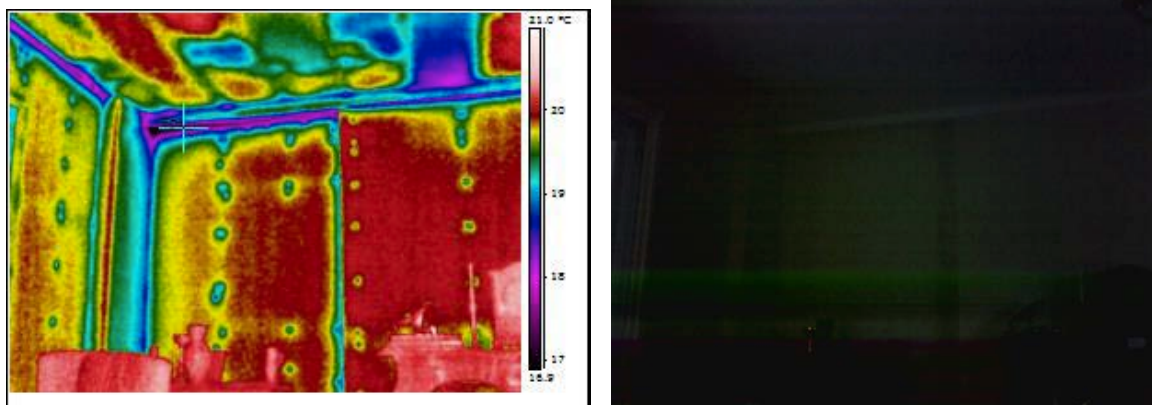
Figure 33 Room F21. The image shows the fixing points of insulation panels and thermal bridge at the junction of first floor ceiling line and external.

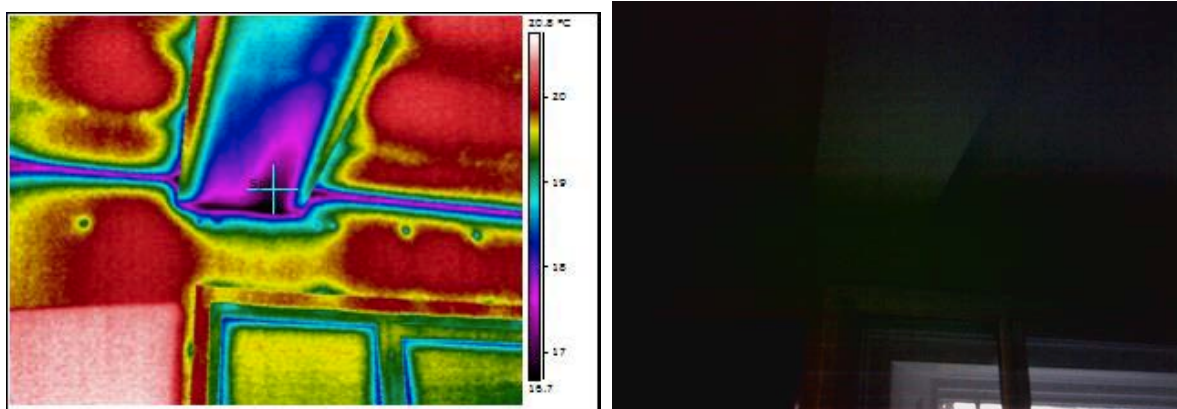
Figure 34 Room F21. The image shows heat loss through the structural beam in the ceiling of first floor.

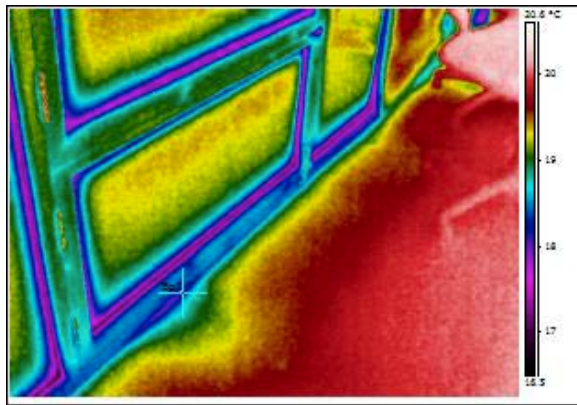
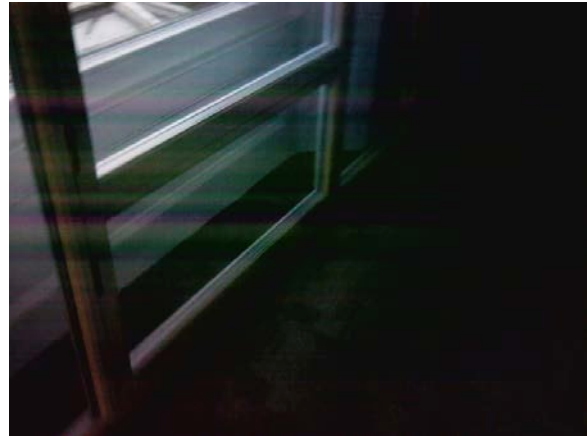
Figure 35 Room F21. The image shows heat loss through the edge of secondary glazing. The smoke test also shows the smoke drawn under the secondary glazing.

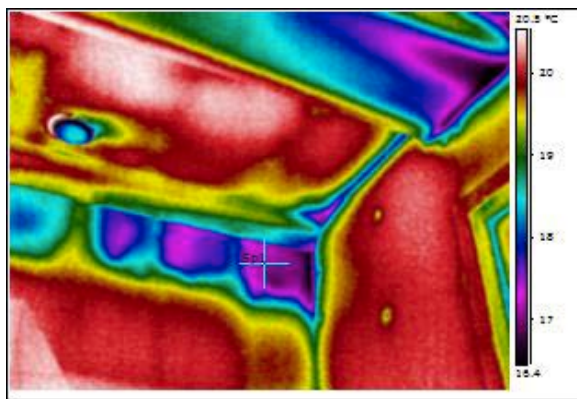
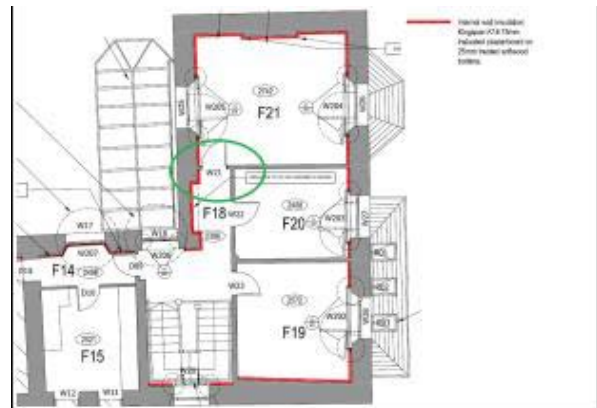
Figure 36 Room F21. The image shows heat loss through the edge of secondary glazing. It also shows the air inlet of MVHR next to the door in room F21.

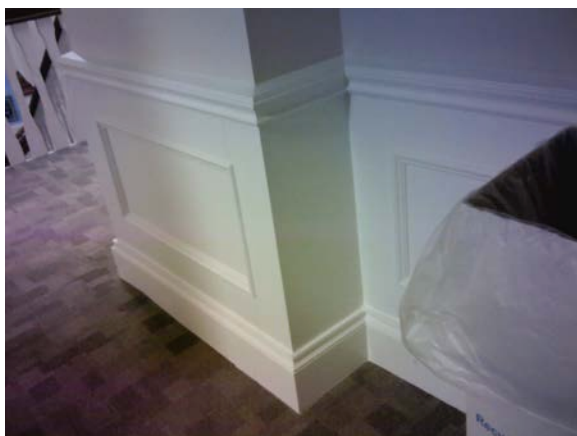
Figure 37 Room F18. The image shows thermal bridge at the junction of first floor floor line and external wall.

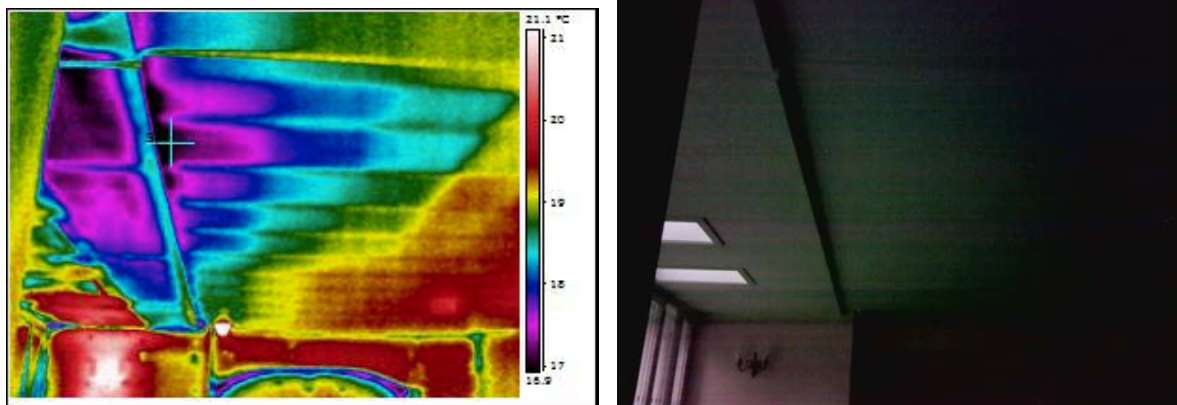
Figure 38 Room G25. Ground floor Council Chamber. The image shows thermal anomalies on the ceiling of the Council Chamber. It is likely to be due to poor insulation of pitched roof above windows.

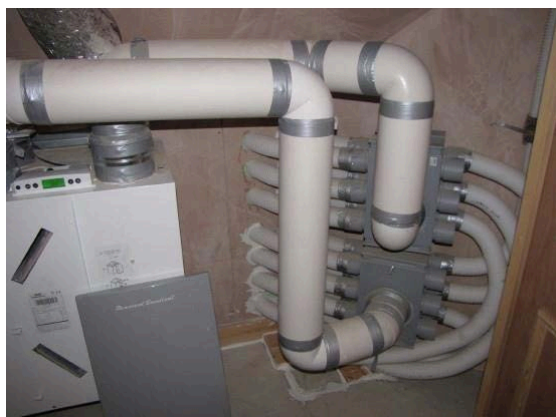
Figure 45 Supply and extract ducts (rigid) serving the supply (top) and extract (bottom) plenum manifolds

The installation, including ducting is of a general, good standard, and proprietary components appear to have been used throughout. Bends on the flexible ducting, used for supply and extract distribution, employ large radii, which is good practice for minimising system resistance. The unit appears to run satisfactorily, and fan speed control (4 position switch in kitchen) functions correctly.

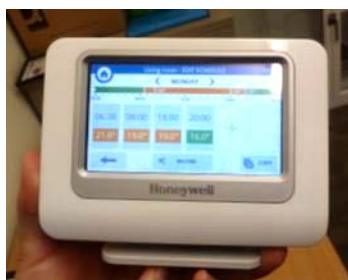
The panel was originally placed in the kitchen (as shown in the User Guide), but the wi-fi signal in there was weak and the panel was moved to the chief officer's room. As a result, it is not easily accessible by staff members when the office is closed. The control was positioned close to a radiator, possibly affecting the thermostat sensor. The screen provides useful labelling and is easy to use. The users, however, do not find it intuitive and were not able to use the control effectively. Also, as there is not a good indication of system response, the users are not sure whether the control is actually connected to the boiler. Issues with the wi-fi connection were reported undermining the reliability of the control. Furthermore, the fact that the old thermostat control has not been removed after the refurbishment creates further complications.

The control allows for different setting on a daily and weekly basis but does not provide any zoning.

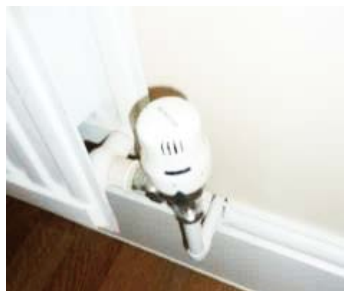
Radiator valves

The radiator valves in the first floor offices are easy and intuitive to use. The scale is from 0 to V and provides good degree of fine control. Most valves were found to be set at III.

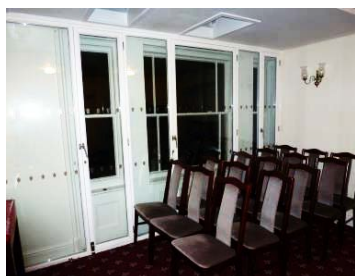
Ceremony room windows

The windows in the ceremony rooms are often blocked by the furniture of the space and cannot be opened.

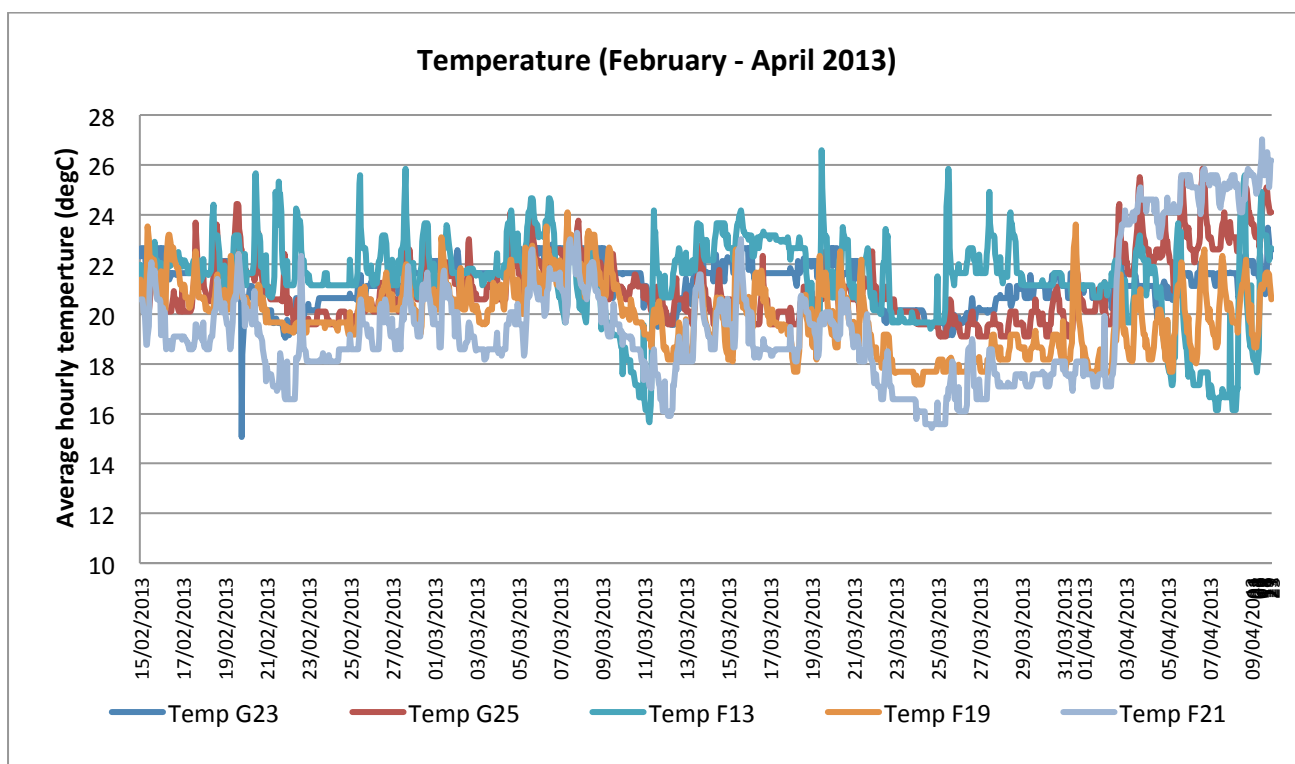
Figure 66 Average hourly temperatures before refurbishment (February-April 2013)

Figure 66 shows the average hourly temperatures recorded in the Garth before the refurbishment during the period from February to April 2013. It should be noted that the heating was on continuously at that time. As a result temperatures range from 18-26°C in most rooms, even when rooms are not occupied and throughout the night. These patterns and high temperatures explain the high gas use before the refurbishment.

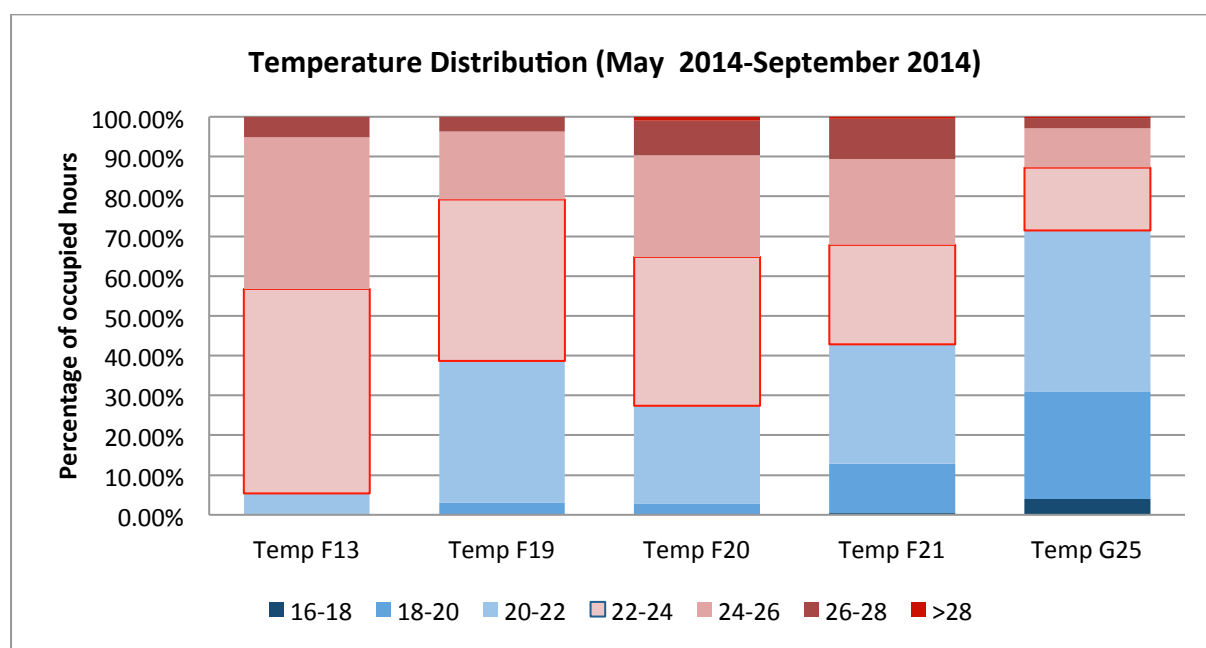
Figure 72 Percentage of occupied hours at a given temperature during May-September 2014 (red borders indicate recommended temperature 22-24°C in summer by CIBSE Guide A)

Figure 72 shows the temperature distribution during occupied hours from May to September 2014. The red box in Figure 72 highlighted the percentages within CIBSE operative temperature ranges. Note: 'occupied hours' are 9am – 6pm of weekdays. It shows that:

- Over 36% of occupied hours in room F13, F19 and F20 are within CIBSE Guide A temperature recommendation.
- 38% of occupied hours in room F13 are between 24-26°C and 5% are between 26-28°C.

- South facing rooms at first floor have more chance of experiencing higher temperature, e.g. 9% of occupied hours in F20 and 10% of occupied hours in F21 are within temperature of 26-28°C.
- 1% of occupied hours during monitored period in office F20 have exceeded the overheating CIBSE Guide A criteria (28°C). No other room shows instances of overheating.
- Lower temperatures are recorded in Room G25 because it is not always occupied.

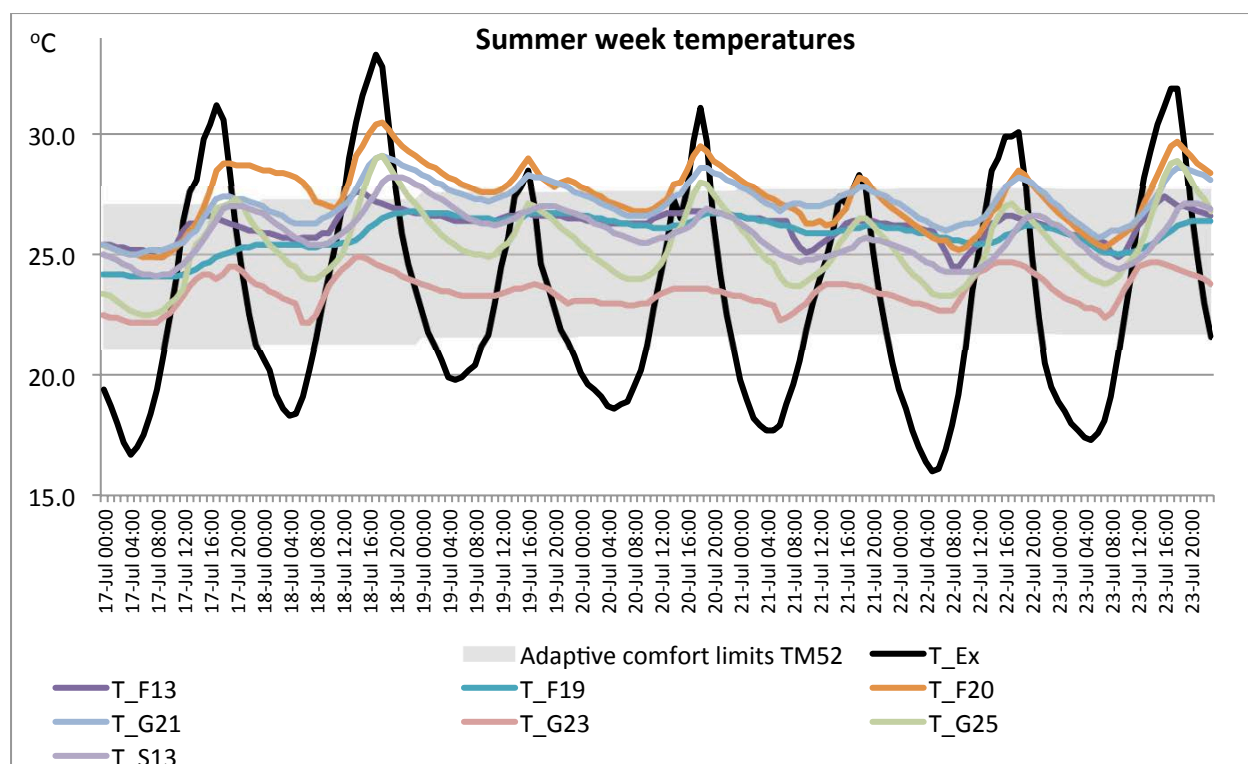
Figure 75 Indoor temperature at the hottest week in 2014

The hourly indoor/outdoor temperature at the hottest week in 2014 is plotted in Figure 75 and it was compared with the adaptive thermal comfort range defined by CIBSE TM 52. Temperatures in F13 on 17, 18 and 23 July have exceeded the upper limit of adaptive thermal comfort zone for category II occupancy group (Normal level of expectation, used for new buildings and renovations).

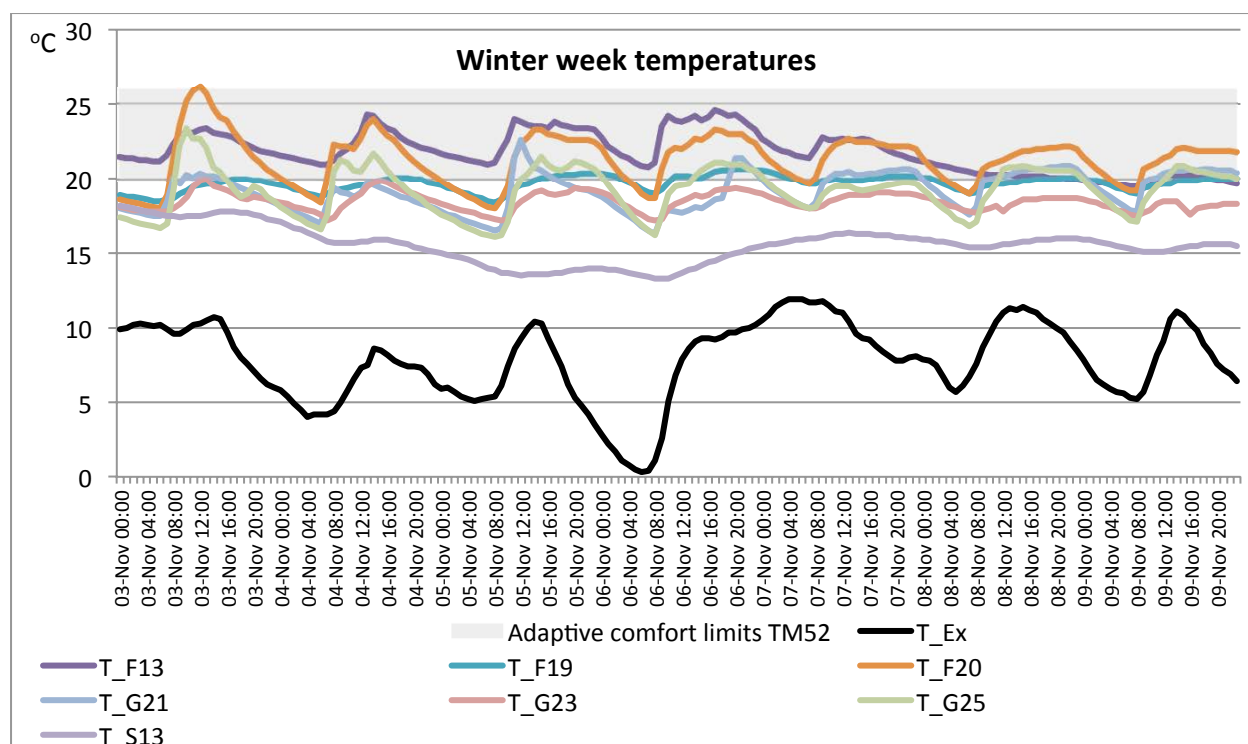
Figure 76 Indoor temperature at the coldest week in 2014 (by 10th November 2014)

The hourly indoor/outdoor temperature at the coldest week in 2014 (by 10 November 2014) is plotted in Figure 76 and it was compared with comfort range defined by CIBSE TM 52 (20-26°C). F13 is hottest room in winter due to its high internal heat gain from equipment and people. The registry office (G23) is the coldest room because it is not insulated as part of this project. It is a 'control' room (for comparison).

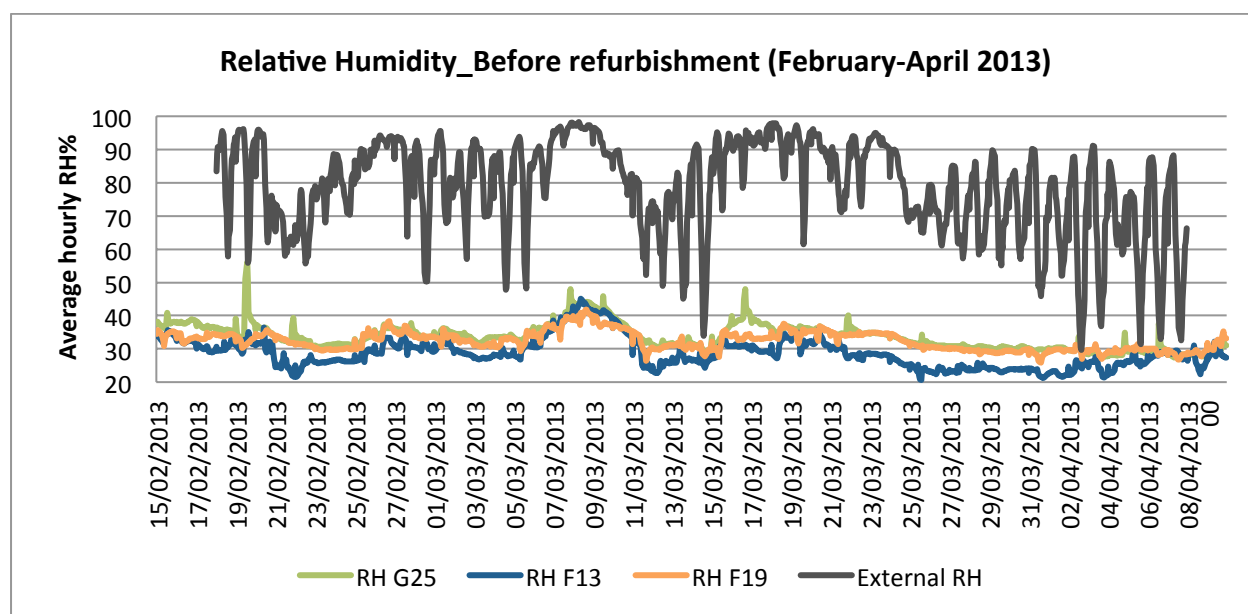
Figure 80 Average hourly RH levels before the refurbishment (February-April 2013)

As shown in Figure 80, RH levels during winter before refurbishment were low, ranging between 20-40%, as a result of continuous heating. After the refurbishment, and with the help of the MVHR system, RH levels during winter range between 30-40% in Room F13 and 35-55% in Room G25, values that are closer to the CIBSE recommended limits of 40-70% (Figure 81).

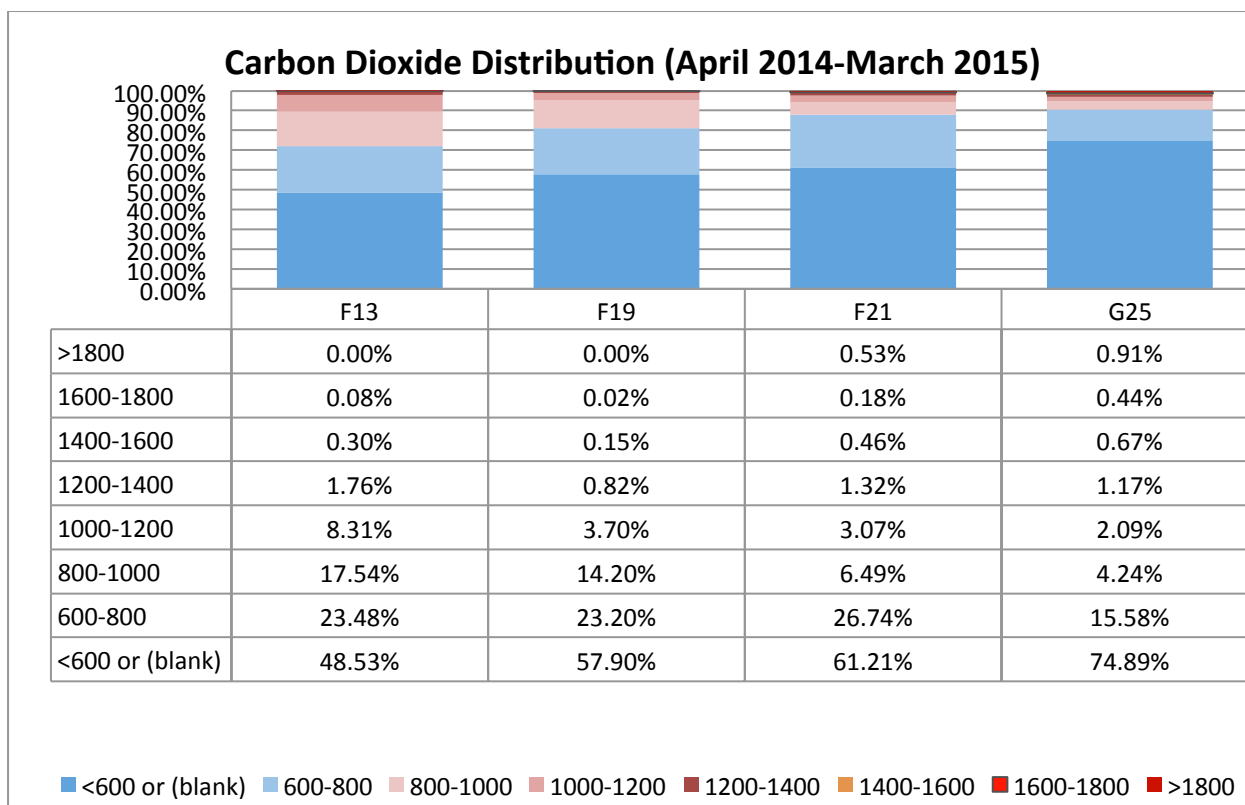
Figure 89 Percentage of occupied hours at a given CO₂ concentration range during 26 April – 30 June 2014

As shown in Figure 89, the air quality in monitored offices is very good as over 70% of occupied hours are below 800ppm CO₂ concentration. In Room G25, 2.1% of occupied hours exceeded 1400 ppm CO₂ concentration due to the large number of occupants. These findings suggest that the MVHR system performing well.

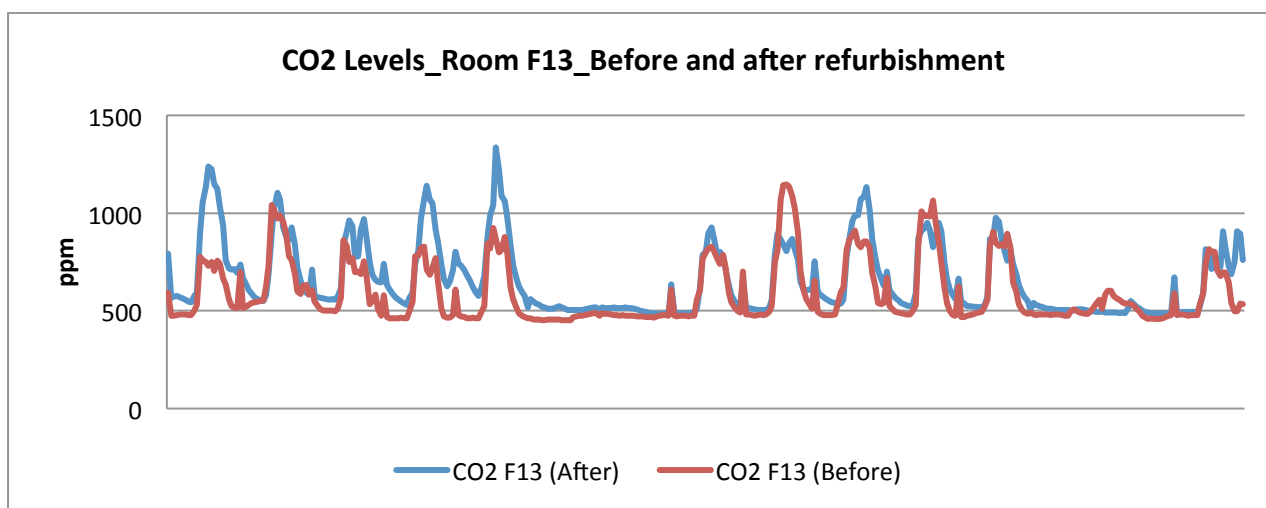
Figure 90 Room F13. CO₂ levels before and after refurbishment during winter (February-March 2013 Vs February-March 2015).

Figure 90 shows a comparison between CO₂ levels recorded during the months of February and March before and after the refurbishment in Room F13. It should be noted that the number of occupants remained unchanged. CO₂ levels before the refurbishment appear to be slightly lower. This is probably due to the high air-permeability levels of the old fabric.
