Innovative Refurbishment, Garth House, Bicester

Final report
1204_DECC_Phase 2
Final Version – 15 January 2016

Submitted to:
Innovate UK

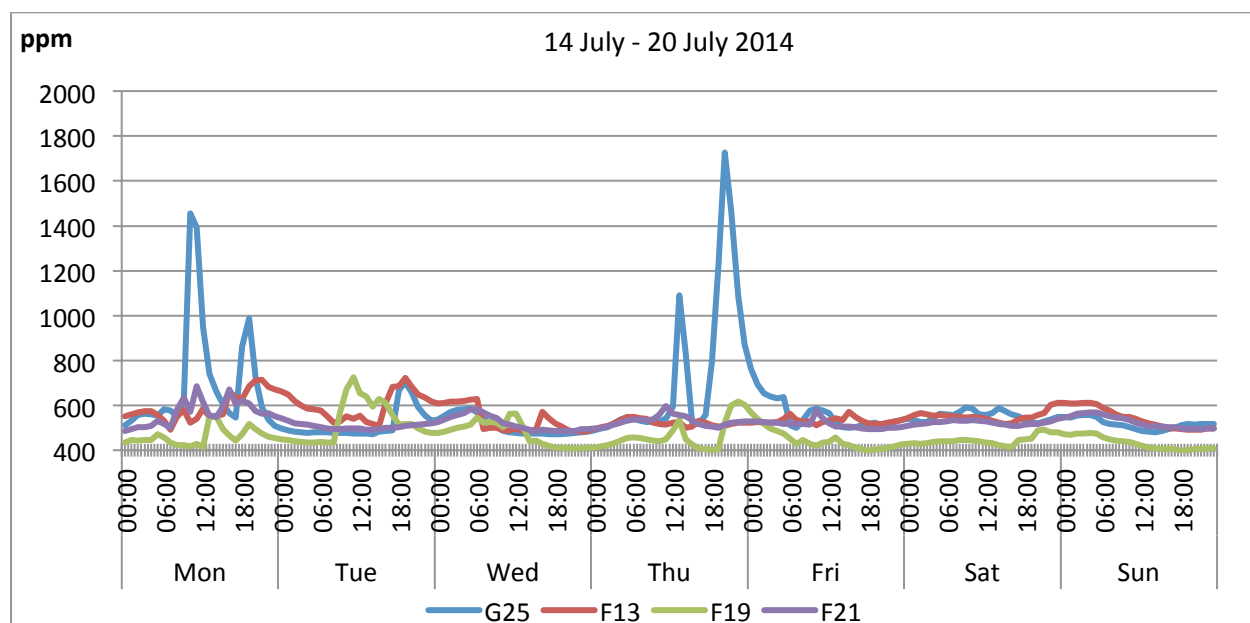
The CO₂ concentrations in a typical summer week (the starting at 13th July 2014) and a winter week are illustrated in Figure 91 and Figure 92. They show that CO₂ concentrations reach peaks on Thursday evening and Saturday afternoon in the Council Chamber due to

meetings. And the CO₂ concentrations in winter are generally higher than the concentrations in summer.

Figure 91 CO₂ concentration (ppm) in a summer week

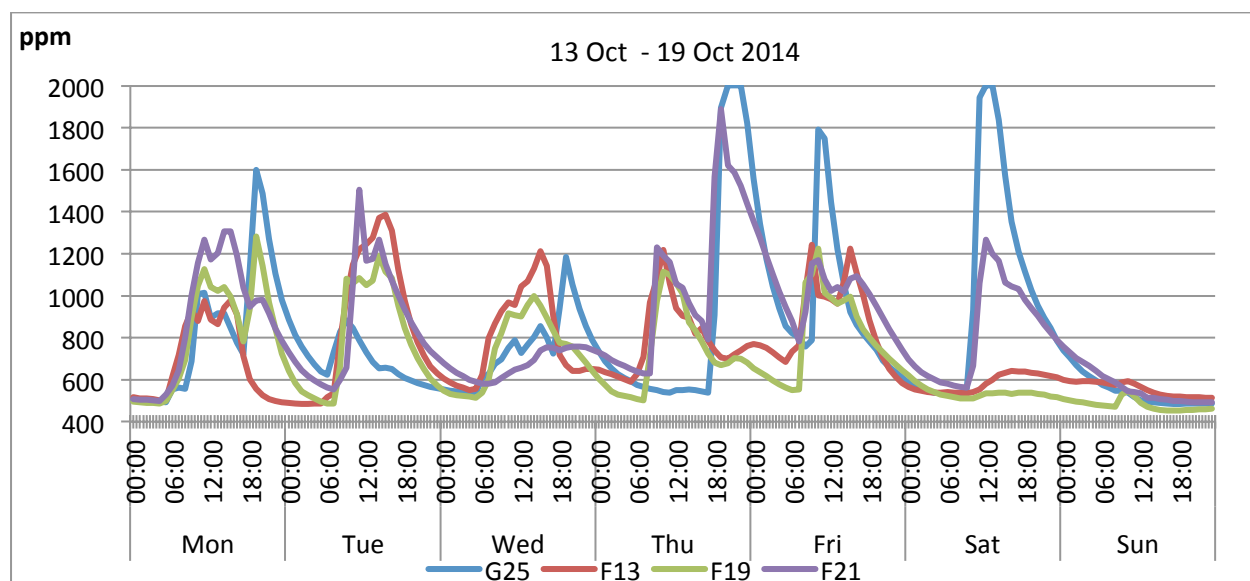
Figure 92 CO₂ concentration (ppm) in a winter week

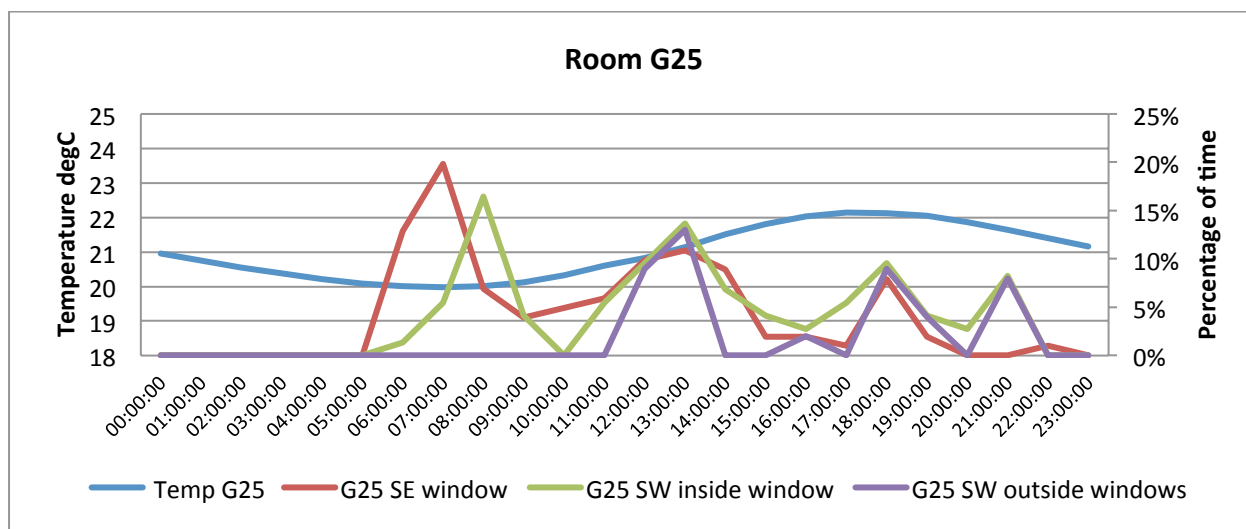
Monitoring data from window opening are cross-related with indoor temperatures in Figure 93-Figure 97 for the period of May to September. As noted by occupants windows mostly remain closed during winter. With the exception of Room G25 where window opening is automatically controlled, window opening occurs during occupancy hours. As can be seen in the graphs, indoor temperatures remain within comfortable levels and appear to drop when windows are opened.

Figure 93 Room FG25. Window opening and indoor temperatures (May-September)

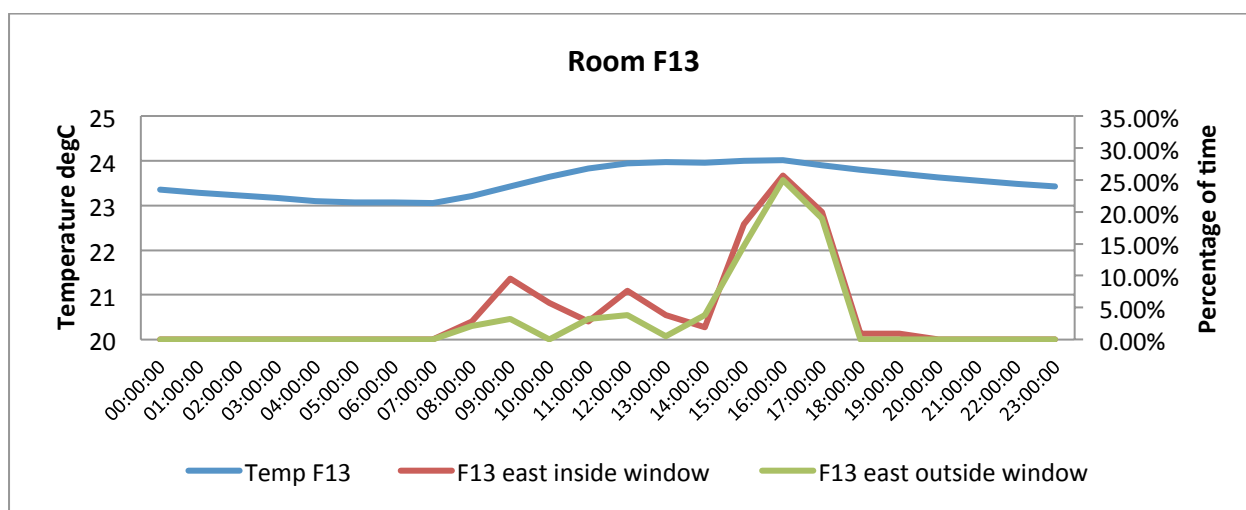
Figure 94 Room F13. Window opening and indoor temperatures (May-September)

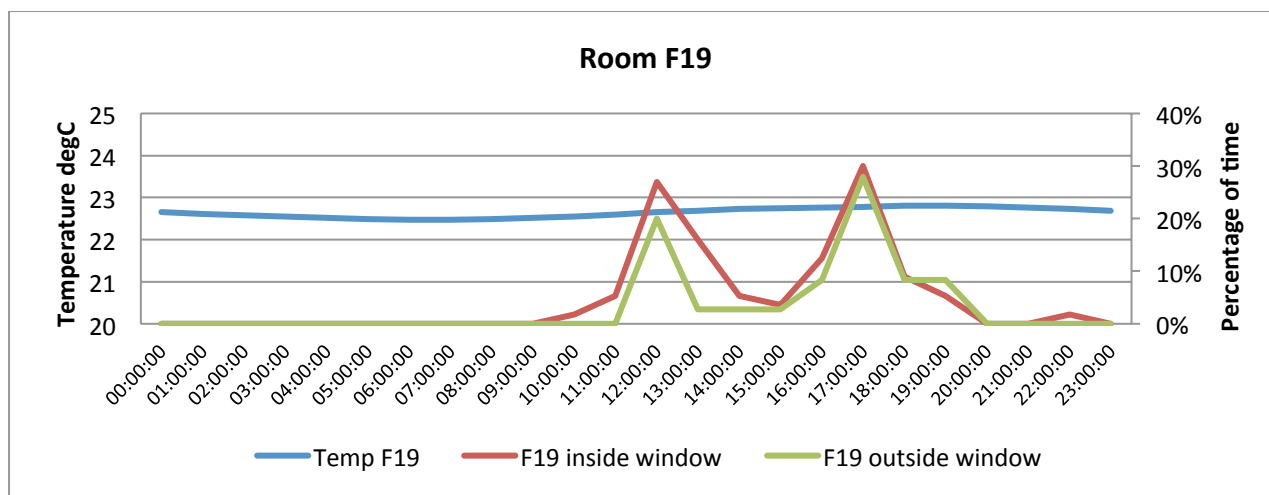
Figure 95 Room F19. Window opening and indoor temperatures (May-September)

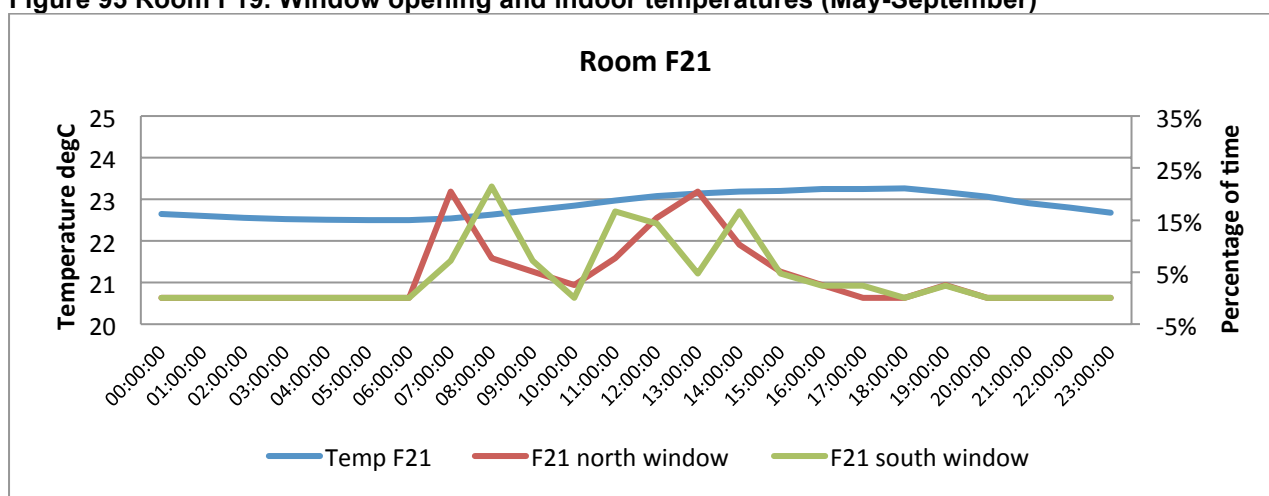
Figure 96 Room F21. Window opening and indoor temperatures (May-September)

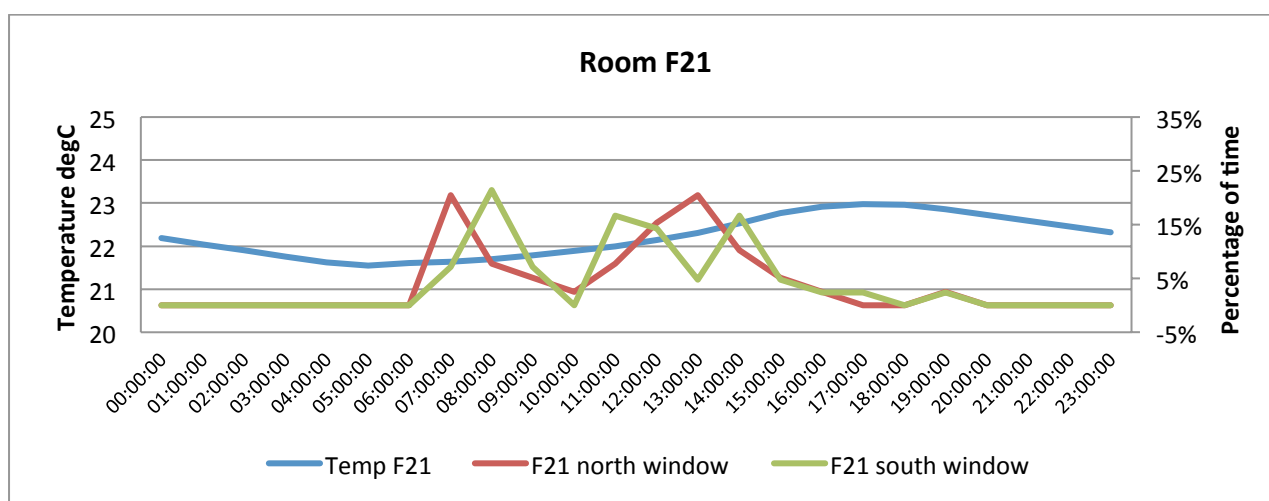
Figure 97 Room F21. Window opening and indoor temperatures (May-September)

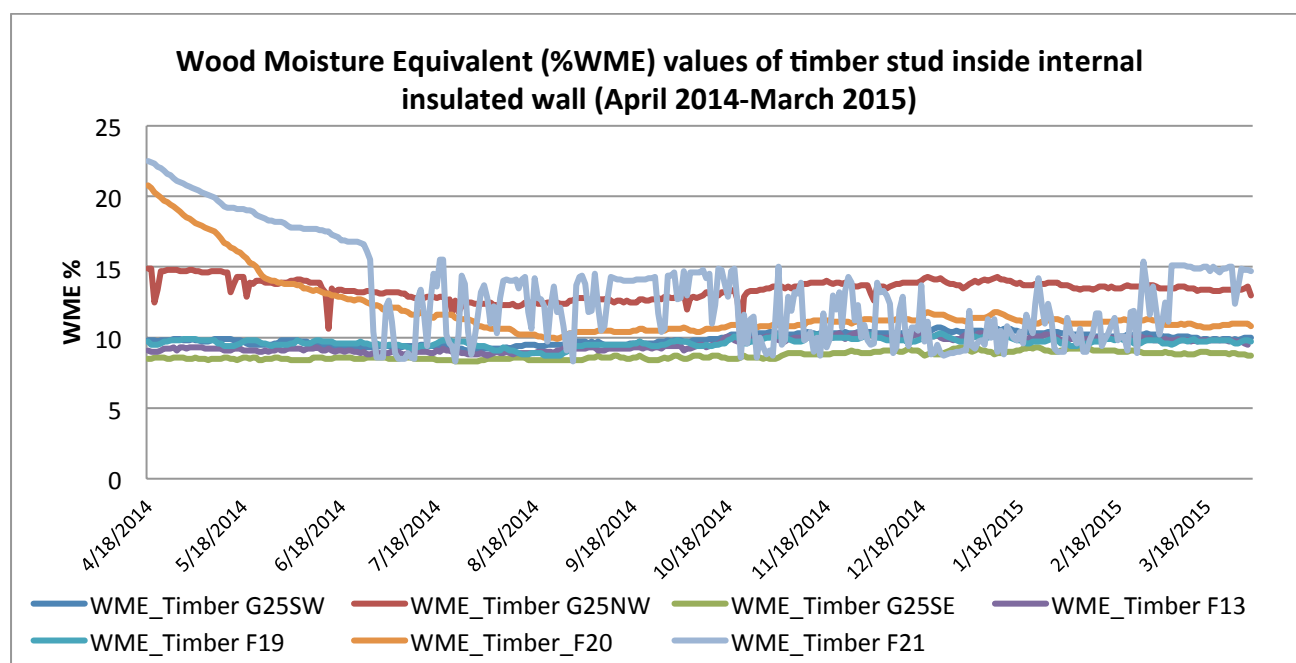
The moisture content of timber studs inside northwest wall of room G25, external wall of F20, southeast wall of F21 were gradually reduced from 22% to 12% over the first three months (Figure 98). The moisture content of external wall (Figure 99) and floor joist (Figure 100) stays relatively stable. They all stay below 20% moisture content above which rot does not develop. Note that wood does not feel damp below 30% moisture content (at round 97% or 98% relative humidity).

Figure 98 Wood Moisture Equivalent (%WME) values of timber stud inside internal insulated wall

- The moisture content of timber studs inside northwest wall of room G25, external wall of F20, southeast wall of F21 gradually reduced from 22% to 12% over the first three months. The moisture content of external wall and floor joist stays relatively stable. They all stay below 20% moisture content above which rot does not develop.

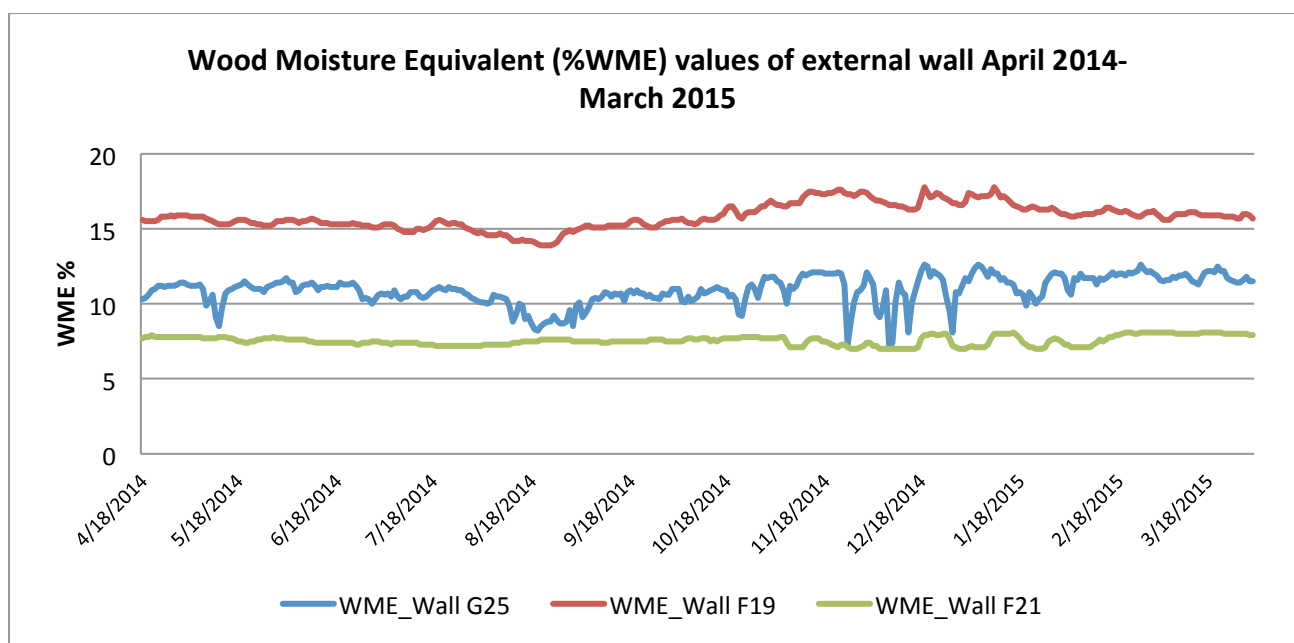
Figure 99 Wood Moisture Equivalent (%WME) values of external wall

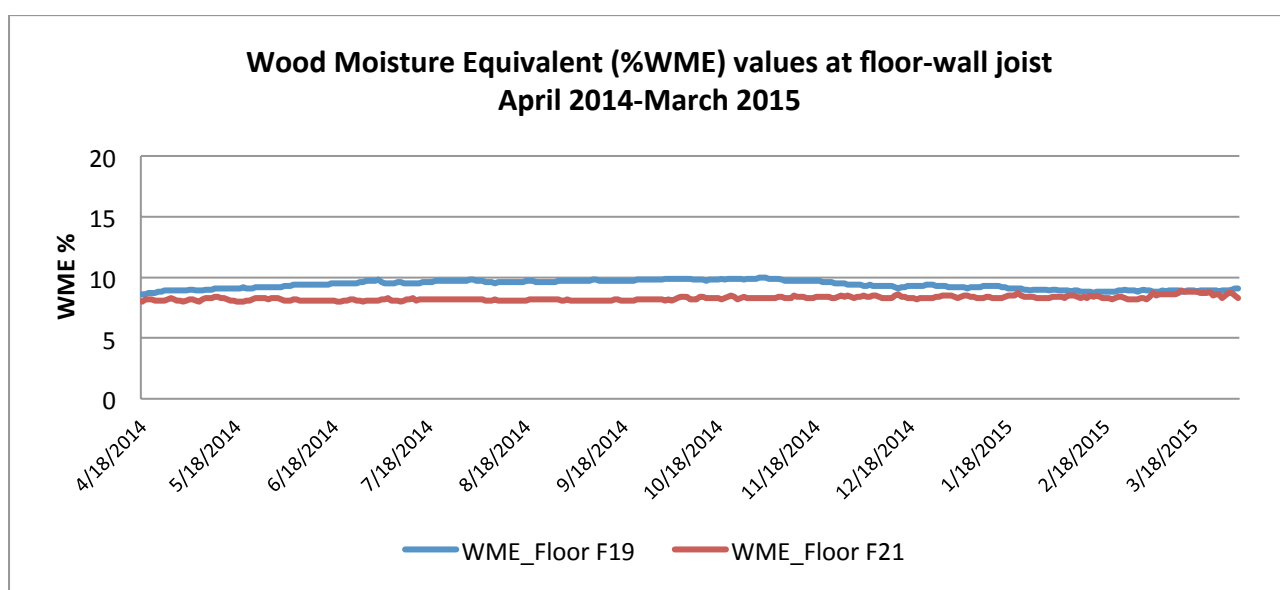
Figure 100 Wood Moisture Equivalent (%WME) values at floor-wall joist

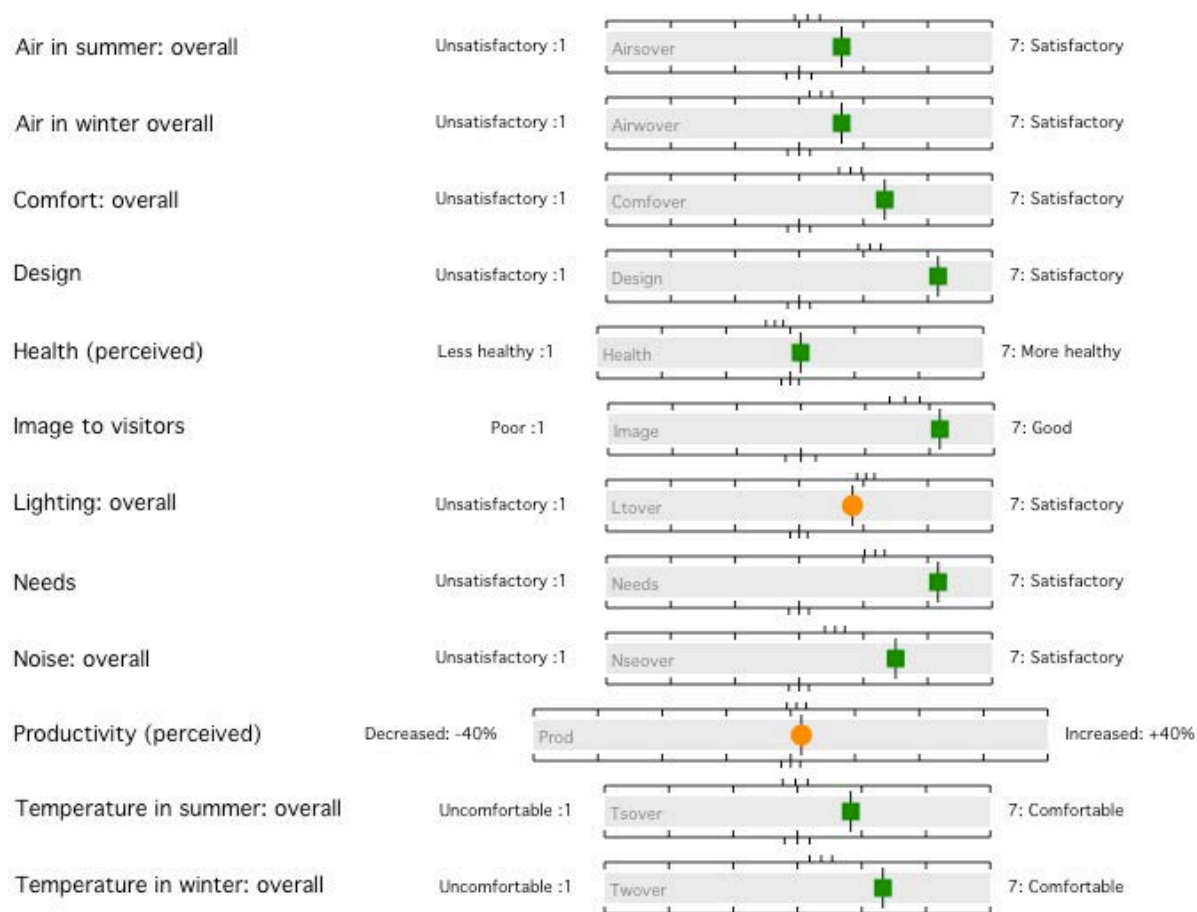
The overall picture of the BUS survey conducted after the refurbishment revealed a very positive opinion of the staff members towards the building with almost all elements (with the exception of lighting and productivity) scoring higher than the benchmark (Figure 101). The design, image to visitors and response to occupant needs are the most appreciated elements. During the last interviews all occupants commented on how nice the building looks from the inside after the refurbishment and pointed out that this is a much nicer environment to work in. Also, office users mentioned that many visitors who were familiar with the old building are pleasantly surprised with the new environment and comment positively about it. Comments made during interviews report that 'The appearance of the building is smarter now. It's more welcoming as an employee and as somebody coming to visit the offices here' and '(following the refurbishment) it is a much nicer building to work in' and that 'The refurbishment has made the building look better and feel better'. Most occupants also reported that the outcome of the refurbishment has greatly exceeded their expectations. 'It looks a lot tidier, a lot smarter, a lot welcoming for people coming to council offices, it's a nice atmosphere for the staff to work in.'

Figure 101. The building overall: after the refurbishment

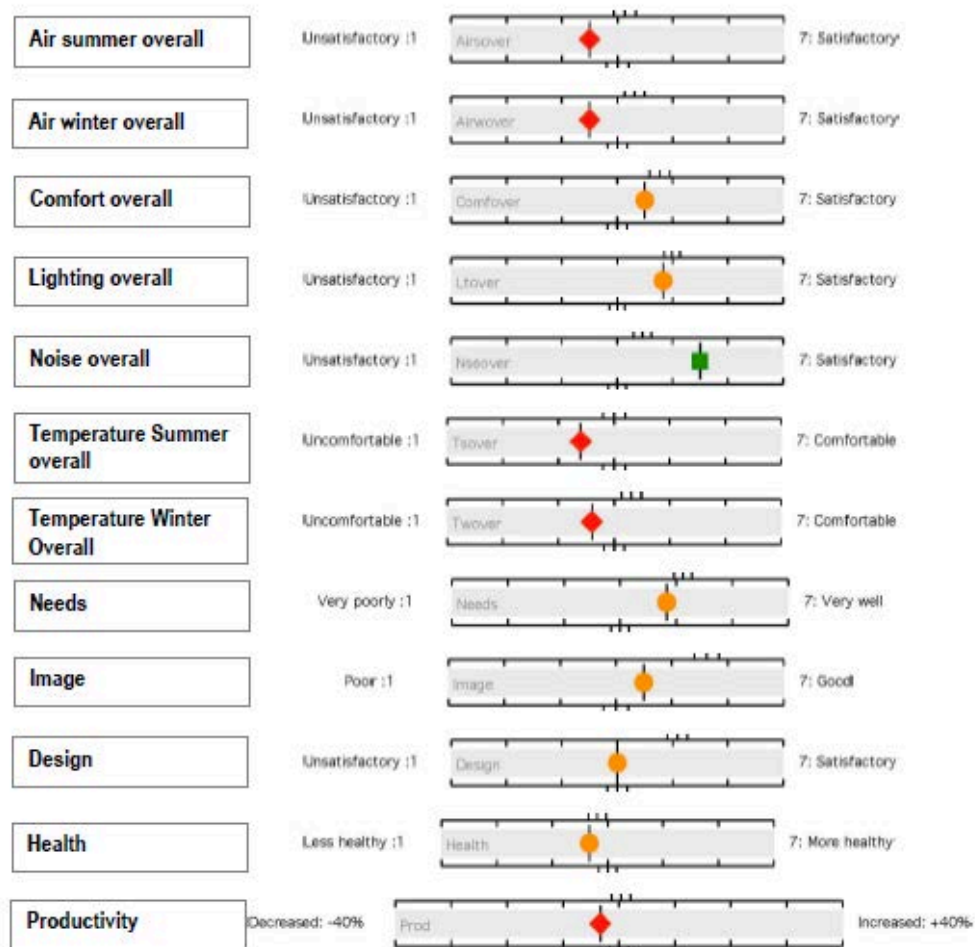
It is interesting to compare these results, with the results of the BUS survey conducted before the refurbishment. Figure 102 shows an overall view of key factors of occupants' satisfaction about the Garth Building, where it can be observed that the overall view is not positive by the dominance of amber and red markers. As can be seen, the only element that scores above the benchmark is noise. All the other factors score within or below their respective benchmarks. Occupants find temperature and air quality unsatisfactory. This would relate strongly to the information gathered from the in-use monitoring (See Section 5.6.2). Interviews with occupants conducted before the refurbishment also revealed that occupants find the air in the building to be stuffy. As well as that, productivity is considered to be below the benchmark. Interestingly, during the second interviews (May 2015) when asked about the effect of the refurbishment on their productivity levels, occupants reported that their productivity levels had not changed: 'It has had no effect on my productivity although it is a nicer atmosphere to work in'; 'I don't think it has affected productivity. We all work very hard. But it's a much more pleasant environment which should help with productivity I suppose'; 'I haven't noticed that I've been more productive or less productive. It's more pleasant because it looks better'. However, the comparison of the two BUS results shows an increase in the rating of productivity. It can be argued that the positive effects of the refurbishment on comfort, makes the occupants more positive in their responses in general.

Figure 102 The building overall: before the refurbishment

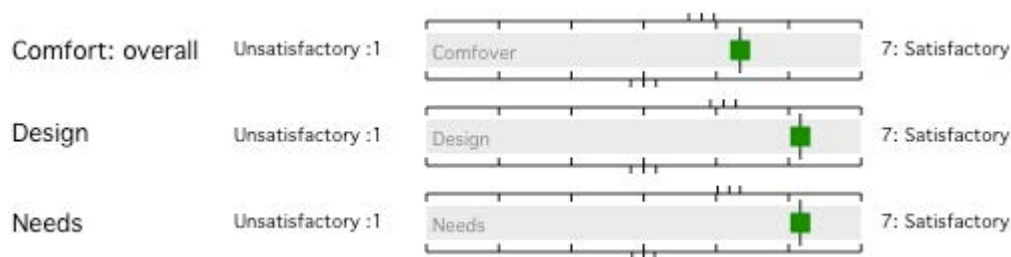
The staff members were asked about their comfort perception within the building relating to the air temperature and quality, noise, lighting, ventilation and level of personal control of these elements. All the participants (6 out of 6) felt that the building was comfortable overall, with comfort scoring higher than the upper end of the benchmark confidence limit (Figure 103).

Figure 103. Overall comfort, design and needs: after the refurbishment

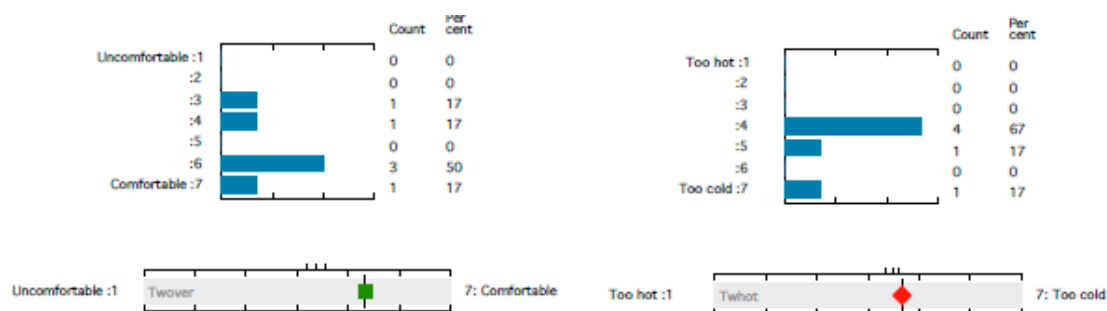
The BUS questionnaires revealed that most people find the spaces comfortable during winter (5 out of 6 participants) and summer (6 out of 6) (Figure 104 and Figure 105). Comments received during the second interviews pointed out that the comfort conditions in terms of temperature had greatly improved during both seasons, with the use of individual heater and fans greatly being reduced following the refurbishment. Occupants commented: 'In the past we nearly all had an electric heater. We don't need them as much, at all now. And the heating thing has been fixed, I may not need one this winter. Before there was at least one heater per person, so probably about 4 and now there's probably one', 'In the summer we used to get fans out to move the air around whereas with this summer we did notice quite a difference with opening the window. We all had a fan each (before)'. Indoor temperature monitoring data also shows that spaces are within the comfort limits during occupancy hours (See Section 5.6.2). Results regarding the 'hot/cold' element of temperature are rated below the benchmark during both winter, however, a closer look reveals that only 1 out of 6 respondents considers temperatures to be 'too cold'. Instead, the majority of respondents rated temperatures as 'neutral' (scale midpoint) during both seasons.

Figure 104 (Left) Temperature in winter overall. (Right) Temperature in winter: hot/cold. After the refurbishment

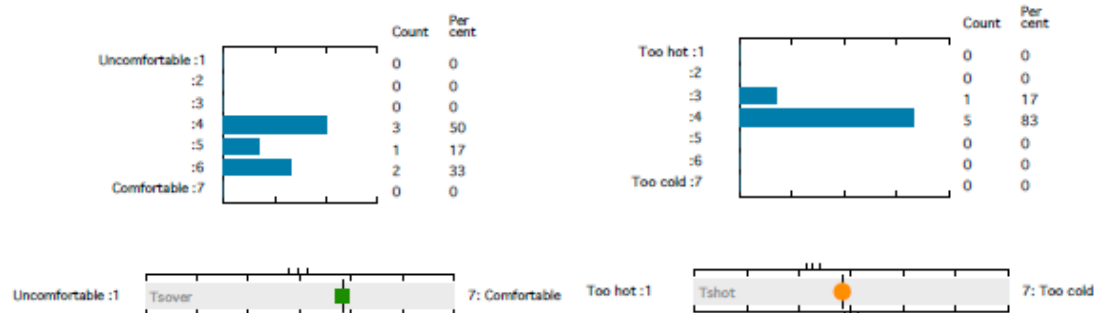
Figure 105 (Left) Temperature in summer overall. (Right) Temperature in summer: hot/cold. After the refurbishment

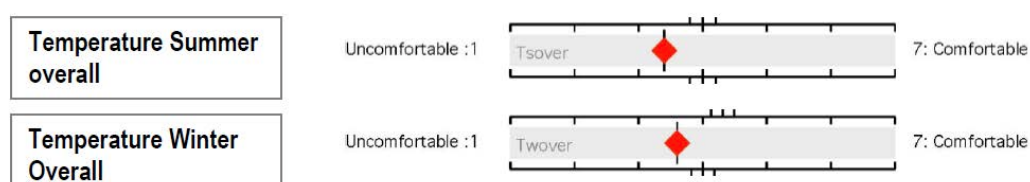
Results from the first BUS survey show that before the refurbishment, temperatures during both summer and winter were not considered comfortable (Figure 106), with the elements scoring below the respective benchmarks. Temperatures were considered 'too hot' during summer and 'too cold' during winter, leading to the use of fans to promote air movement during summer and electric space heaters during winter. The use of these appliances, as well as the use of continuous gas heating during winter to achieve comfort, reflected on the annual energy use of the building.

Figure 106 Temperature in winter and summer: before the refurbishment

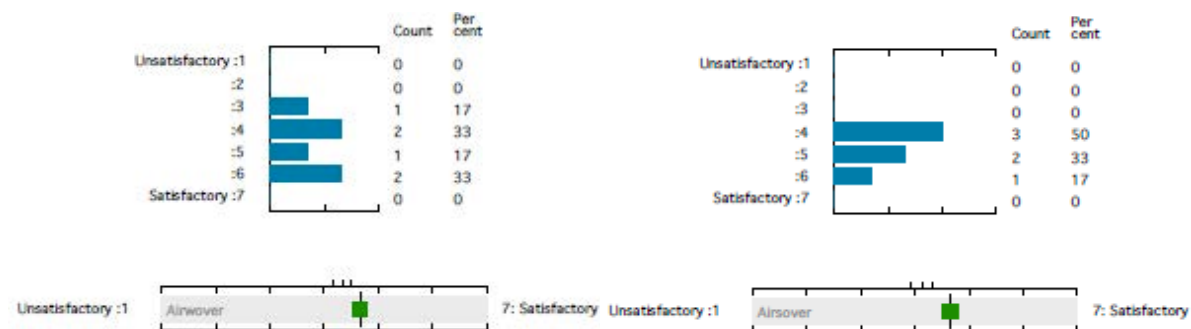
Air quality overall is considered satisfactory, scoring higher than the scale midpoint and higher than the benchmark during both winter and summer (Figure 107).

Figure 107 (Left) Air in winter overall. (Right) Air in summer overall. After the refurbishment

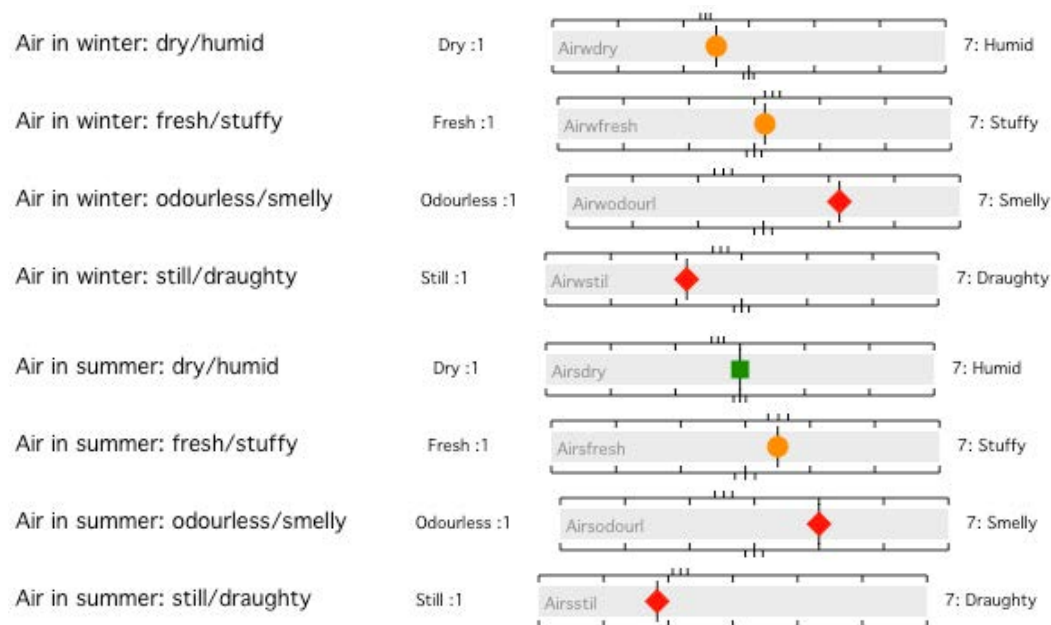
However, air is considered somewhat 'smelly' by the majority of the respondents (5 out of 6) during both seasons (Figure 108). Also, 2 out of 6 respondents find the air 'still', but only 1 out of 6 find it 'stuffy', during winter and summer. Most comments collected during the interviews point out that air quality has improved. The manager mentioned that 'The air quality

Figure 108 Air quality parameters: after the refurbishment

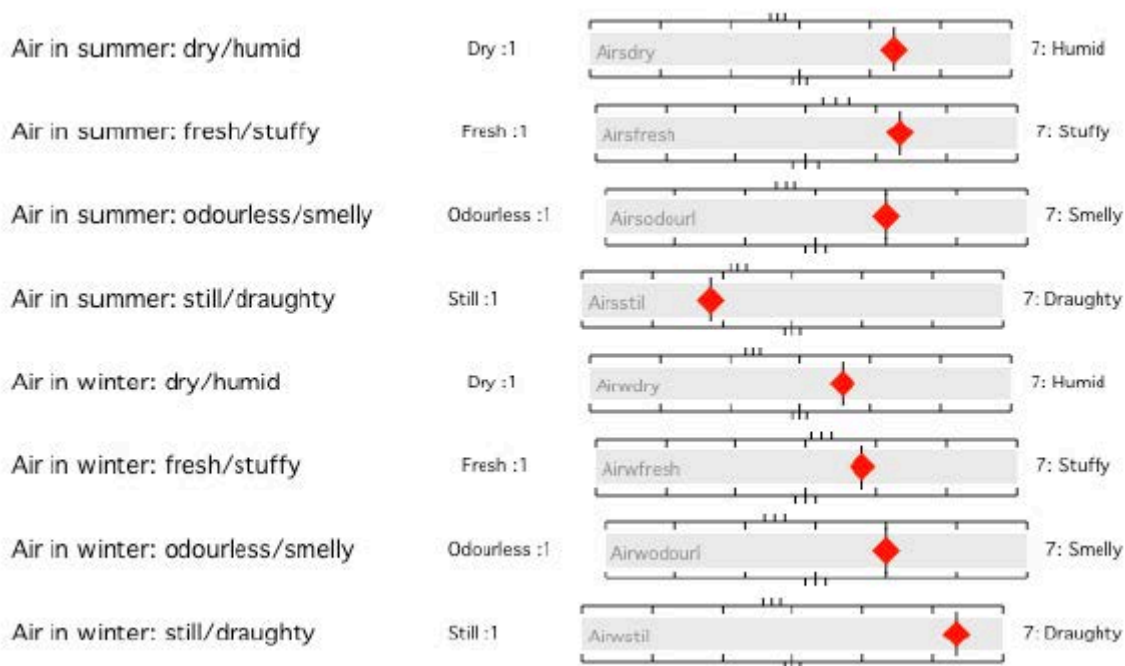
Results from the BUS survey conducted before the refurbishment were significantly worse (Figure 109 and Figure 110), with all elements and air quality overall scoring below the benchmarks. Occupants had commented that 'The building can smell at times. An old fusty smell from the age of the building.' and 'The more people in the building, the more musty it becomes.'

Figure 110 Air quality parameters: before the refurbishment

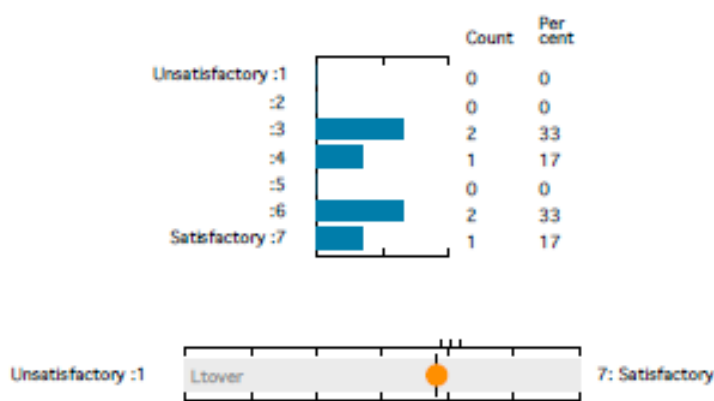
Lighting overall scored similar to the benchmark and above the scale midpoint (Figure 111). These results are similar to the ones collected during the pre-refurbishment BUS survey, which was expected, as the refurbishment did not involve any measures regarding lighting. As shown in Figure 112, artificial lighting scored below the benchmark and towards the 'too much' end of the scale, however, 4 out of 6 respondents find artificial lights to be satisfactory. Natural lighting also scored below the benchmark, with 2 out of 6 respondents finding it 'too little'. One respondent added in the BUS comments that 'Can find overhead lighting a little too bright. Unable to switch off individual lights. Colleague has had light bulbs removed from lights above her.' The same was reported during interviews: 'The light in our office is a big issue because before each strip of light had its own switch and now they are all controlled by one switch, so the one close to the window we took the bulb out because we don't want that light on. Very rarely do we want that on especially when it's sunny'.

Figure 111 Lighting overall

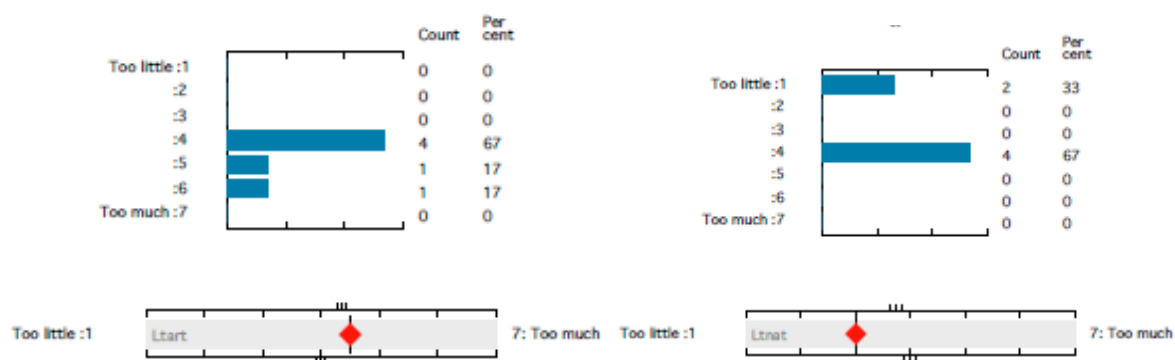
Figure 112. (Left) Artificial lighting. (Right) Natural lighting

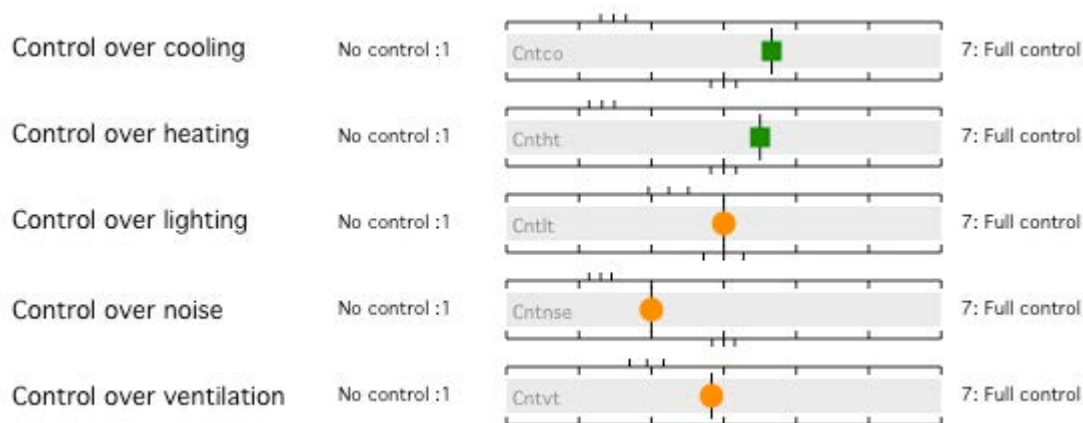
Control over heating and cooling scored above the benchmark and above the scale midpoint (Figure 113). The majority of the respondents (4 out of 6 and 5 out of 6) feel they have good control over heating and cooling respectively. Control over lighting, noise and ventilation scored within the benchmark. During the last interviews, occupants reported that they do not control the heating thermostat (which is controlled by the manager), but do control the radiator valves. Despite the positive rating however, it was revealed during the interviews that the manager was not very familiar with the operation of the thermostat. Furthermore, the other member of staff involved in the operation of the building was mistaken about the location of the new thermostat control. As mentioned in Section 5.3.2, the old thermostat control (located in the Ground Floor) has not been removed thus creating some confusion among building users.

Figure 113 Control after the refurbishment

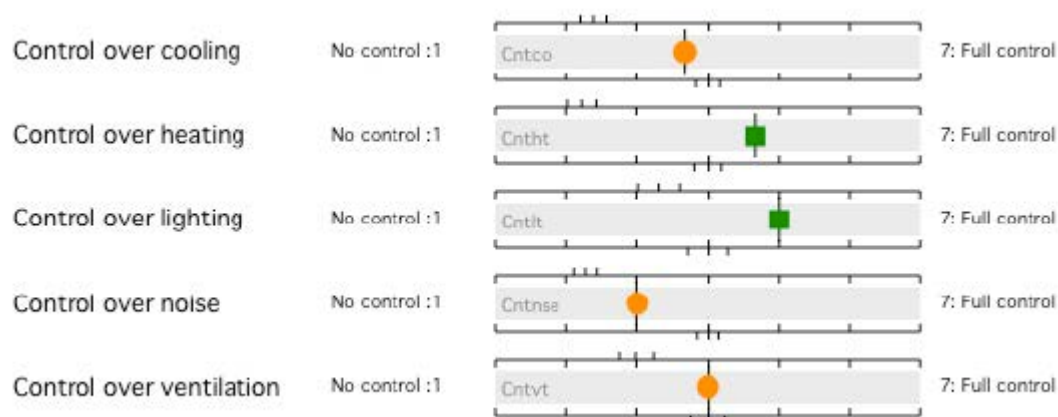
As shown in Figure 114, before refurbishment, control over cooling had scored lower. However, control over lighting had scored higher. This is related to the fact that after the refurbishment lights in room F13 are only controlled by one switch, which creates some control issues and conflict among office users, as reported above.

Figure 114 Control before the refurbishment

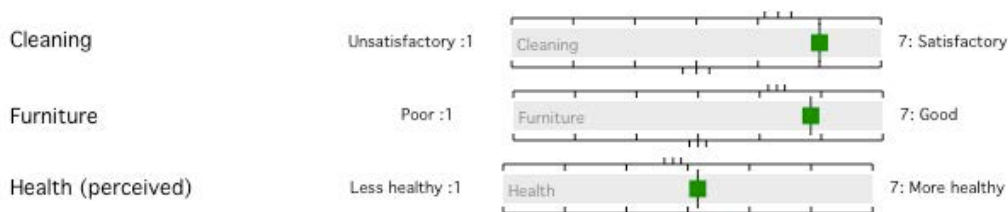
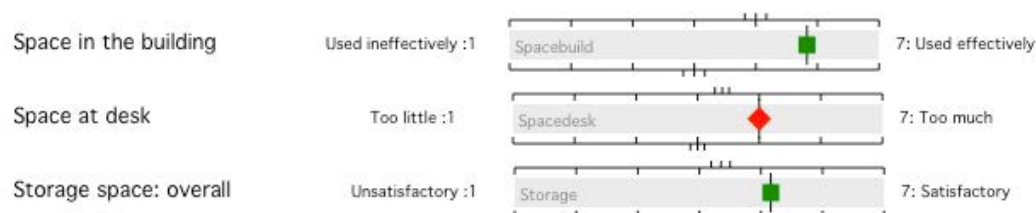
Elements related to cleaning, furniture and perceived health all scored above the benchmark (Figure 115). The same applies for elements such as space in the building and storage space available. Space at desk scored below the benchmark, falling towards the high ('too much') end of the scale. The administration staff sharing Room F13 reported that: '(The refurbishment) made us utilise the space better. I wouldn't say that I feel we've got more or less space' and 'We gained a little bit of space in our room. We fit in a bit better. Where I was sat before wasn't ideal but now it works better'.

Figure 115 Facilities management elements: after the refurbishment
